## Program and Recreational Resources

### Circulation

### Visual Qualities

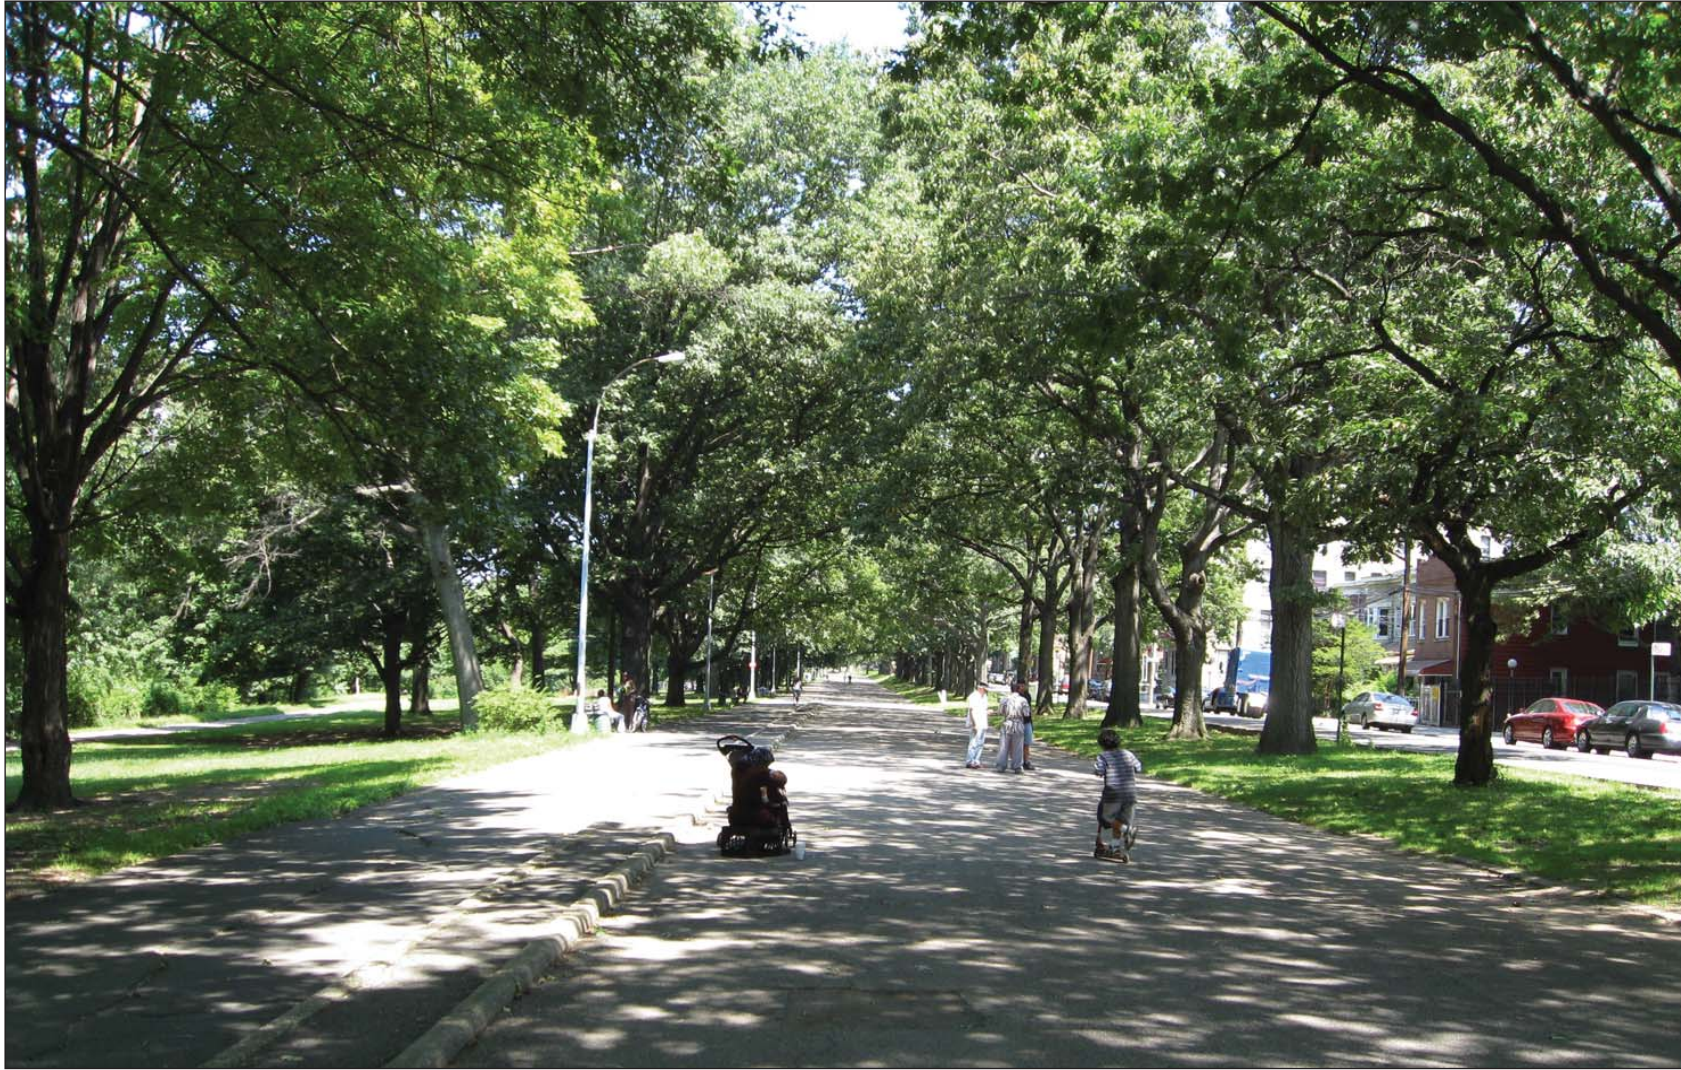
View looking north along the multi-use greenway path from the 211th Street entry area

The historic road-bed of the Bronx River Parkway is used as a multi-use path through the park. The approximately forty-foot-wide path is occasionally subdivided by raised curbs that act as small medians. As an abandoned road-bed, the asphalt pavement gives few visual cues that is a pedestrian path and is in poor condition. A series of seven foot-wide asphalt paths run through the park. These are also in a state of disrepair with damage caused by extensive stormwater runoff. Additionally there is a seven foot-wide wide asphalt path that is adjacent to the river's edge.

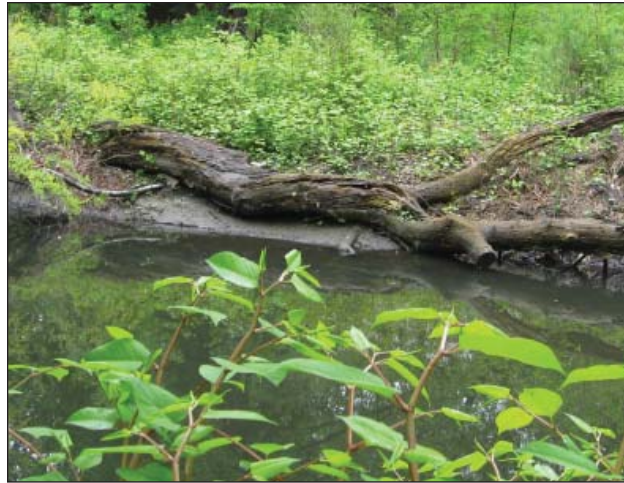
An invasive species, Japanese knotweed, dominates large areas of shoreline and limits open views of the water

- Significant colonies of invasive species contribute to the creation of a vegetative wall that closes off views to the water from much of the eastern bank during spring, summer and fall months.

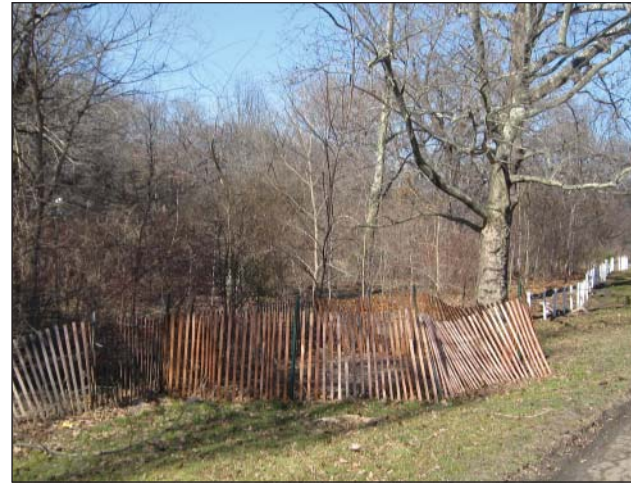
Fencing at native restoration planting areas is instrumental in the success of plant development but requires routine maintenance

- Previously completed native restoration planting areas at the river banks are off-limits to foot traffic and have been enclosed by a variety of restraints, including wood picket snow fence, wire mesh fence, and hedge rails constructed with wooden posts with plastic chains. While restricted access has been instrumental to the success of new restoration plantings, the visual inconsistency of fencing types, combined with the need for ongoing maintenance, has resulted in an edge condition that often looks unkept.

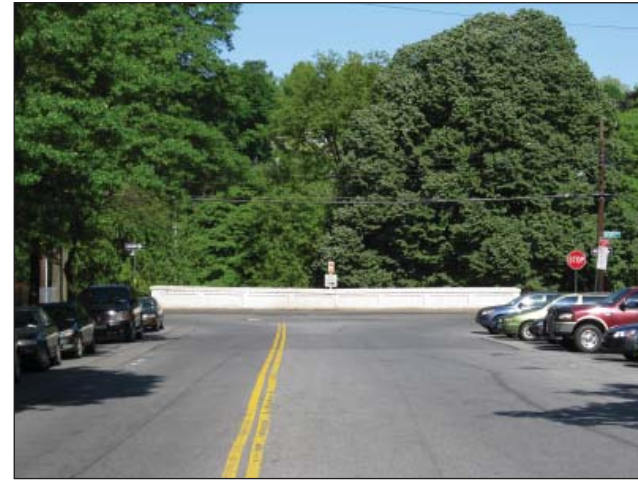
Mature trees located within the park help signal the edge of the parkland and counteract poorly defined park entrances as seen from uphill

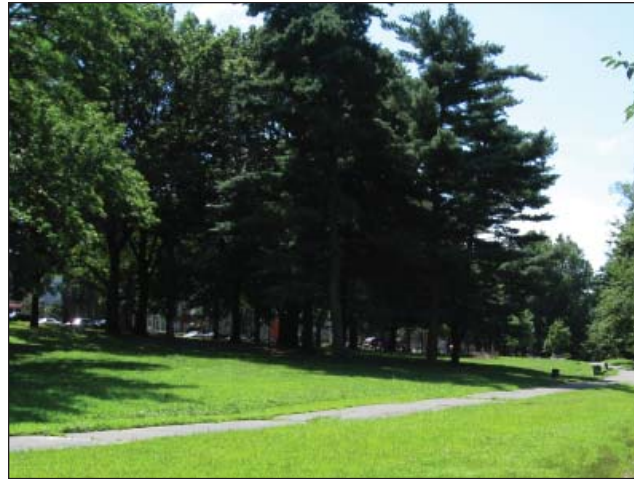
A stand of mature white pines help divide areas of open lawn near the south end of the park and create visual interest

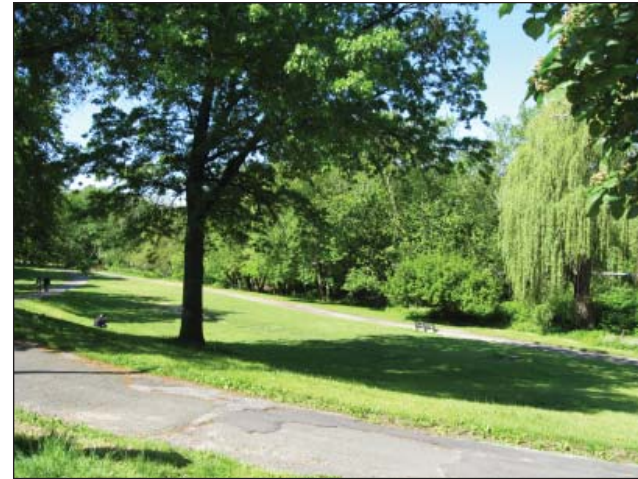
Large areas of lawn create open views across the parkland and promote the visual connection between higher and lower areas of the park

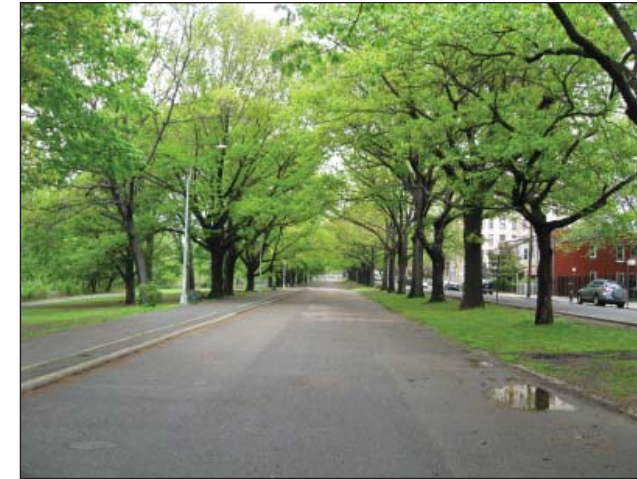
Long views down the multi-use greenway path are a defining visual element of the park

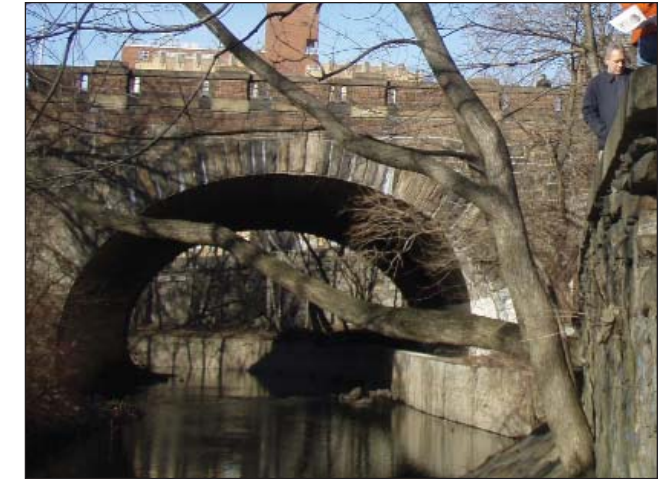
The historic bridge at Gun Hill Road

Built structures such as bridge abutments constrict the channel and have altered hydraulics and indirectly contributed to adverse upstream and downstream conditions, including scouring and high sediment deposition. To prevent scour, the channel sides have been armored with large rocks adjacent to the bridges and roads constructed over half a century ago. In 2001, four boulder veins were installed in the eastern side of the channel within Shoelace Park to increase the hydraulic variation in the channel and attempt to force a scour pool and deflect flow towards the center of the channel. These structures were found to have only a local impact on the channel bed topography, and through the added boulder obstructions created cover where there was none, and a way to get closer to the water, they did not scour large pools in the channel bed.

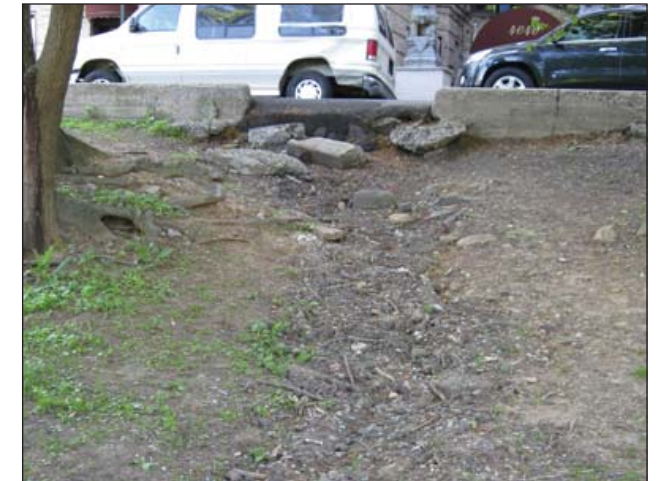
Deterioration of raised curb and slope erosion at Bronx Blvd.

Several factors contribute to severe erosion within the park: the severity of slopes, the low elevation of the park relative to the contributing watershed, and the ultra-urban conditions of the watershed with its high percentage of impermeable surfaces. Almost all of the stormwater runoff, excluding what falls within the parks, enters the park from the upland residential neighborhoods to the east, along Bronx Boulevard and Duncomb Avenue. At multiple locations, the areas of raised concrete curb that define the park boundary along the western side of Bronx Boulevard have been damaged or 'blown-out', creating pinch points where unmanaged concentrated runoff enters the park. Once within the park, runoff flows down slopes and over paved surfaces before continuing along the edge of paved paths that cut across slopes, degrading pavements, depositing sediment, and scouring non-paved areas. Flooding and ponding on paved surfaces also occurs in areas where pavements are damaged or not sufficiently sloped to shed runoff. Unmanaged runoff is not only detrimental to the health of the river but is responsible for the creation of hazardous conditions at park paths that require routine maintenance to uphold the New York City Department of Parks & Recreation (NYCDPR) Parks Inspection Program standards. Damage from runoff is often most severe at the convergence of downhill park paths and riverside park paths in the lower elevations of the park. In steep non-paved areas, especially where the shade from mature trees has suppressed understory vegetation, concentrated surface runoff has created severely eroded channels on the slopes. The sediment carried by surface runoff is routinely deposited on paved lower park paths and carried into the river.

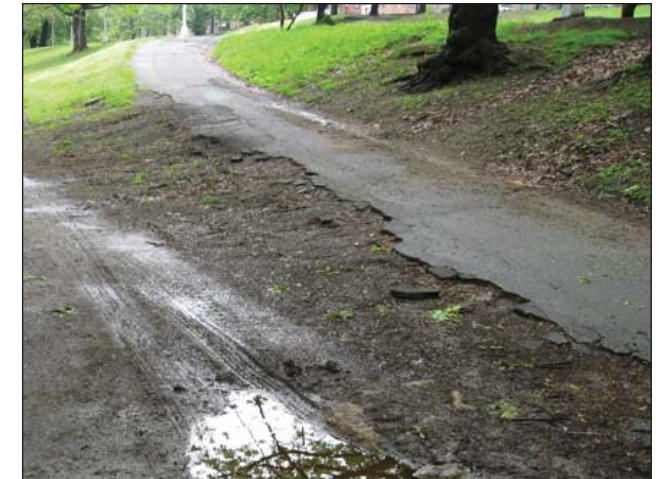
Erosion of asphalt paths at low point in lower terrace area

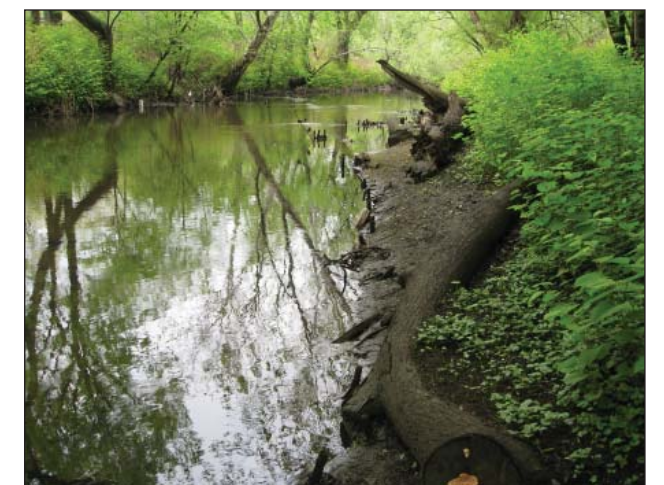
Channel bank restoration with dominant invasive species

in the park is very low and the side slopes of the channel are relatively steep. The steepness of the bank slopes is exacerbated by the dominance of invasive Japanese knotweed, which grows along the tops of the banks and has limited the establishment of native woody riparian species that would grow lower to the water line and create a more thoroughly vegetated bank. All of these geomorphologic conditions further complicate efforts to improve channel habitat and native vegetation populations within the floodplain.

Previous efforts to restore native riparian vegetation along the banks by the Bronx River Conservation Crew and the NYCDPR Natural Resources Group included staking coir logs at the toe of the bank to try to narrow the low flow channel by installing a sediment trapping structure that could be vegetated, and terracing the banks to facilitate planting. Log cribbing has also been used in two locations to stabilize channel slopes and prevent erosion associated with overland runoff. The channel bank restoration efforts in particular have shown mixed results, potentially because many of the planted areas have reverted to dominance by Japanese knotweed or Japanese hops. Areas on the west bank where the channel side slopes are particularly steep and difficult to access are especially difficult to plant and maintain, and are frequently colonized by invasive species. Flood-related deposition of sediment carrying exotic seeds and propagules (i.e., Japanese knotweed can take root from pieces of rhizomes or stems) has further led to a disturbance regime favoring the spread of invasive species.

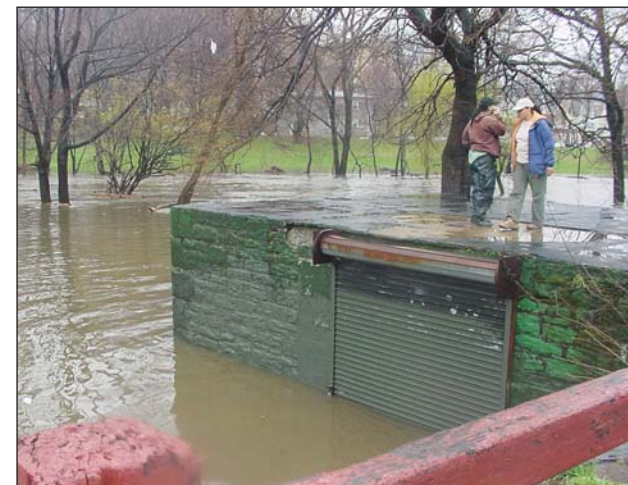
Fort Knox West in flood, Spring 2007

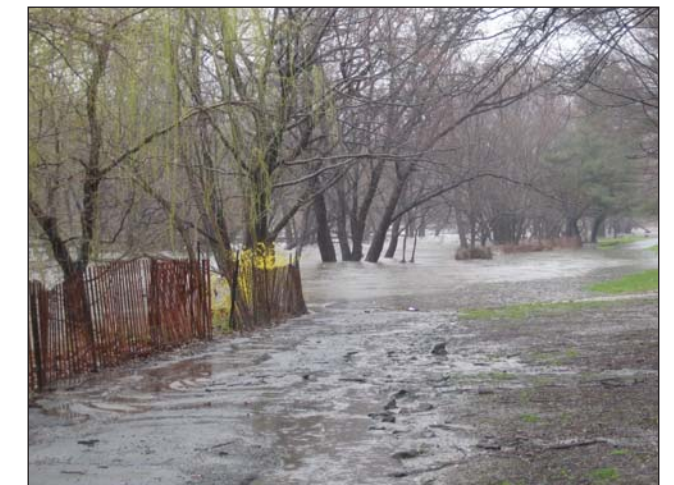
Lower Shoelace Park during Spring 2007 flood

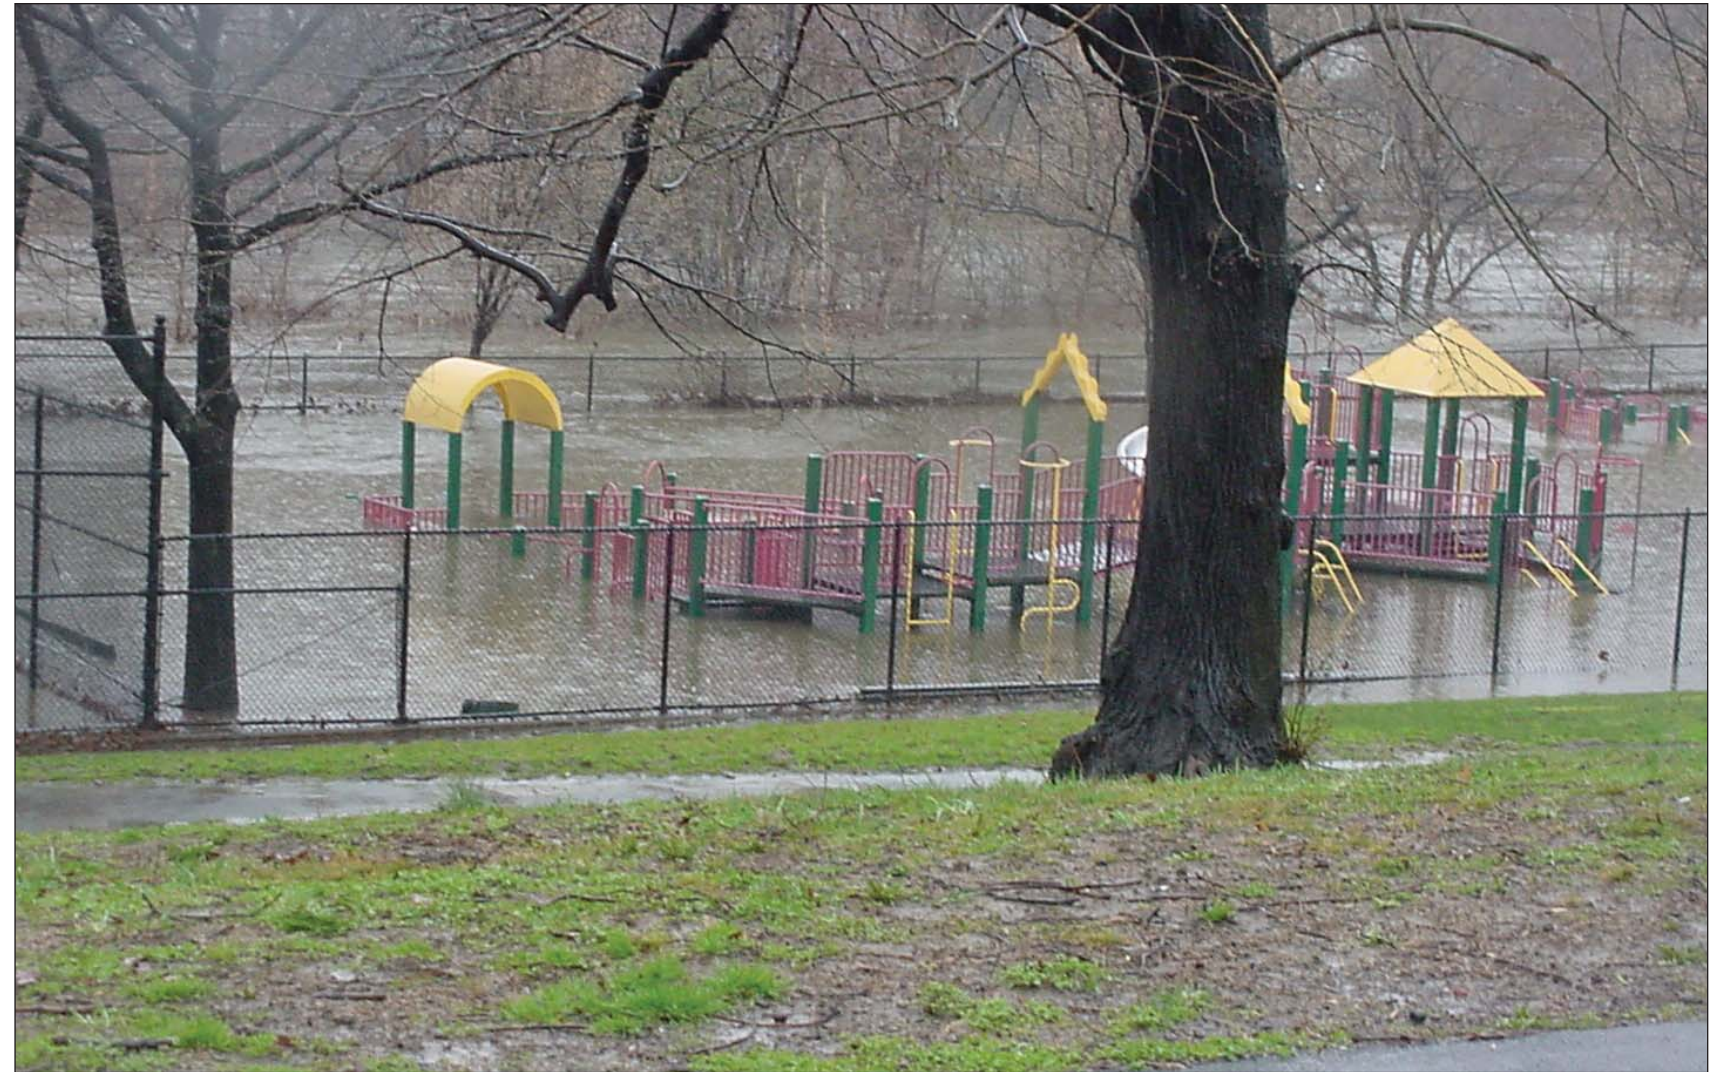
Olinville Playground in Flood, Spring 2007

**40% of the park landscape is within the 100-year floodplain. Built structures such as playgrounds and comfort stations are regularly inundated.**

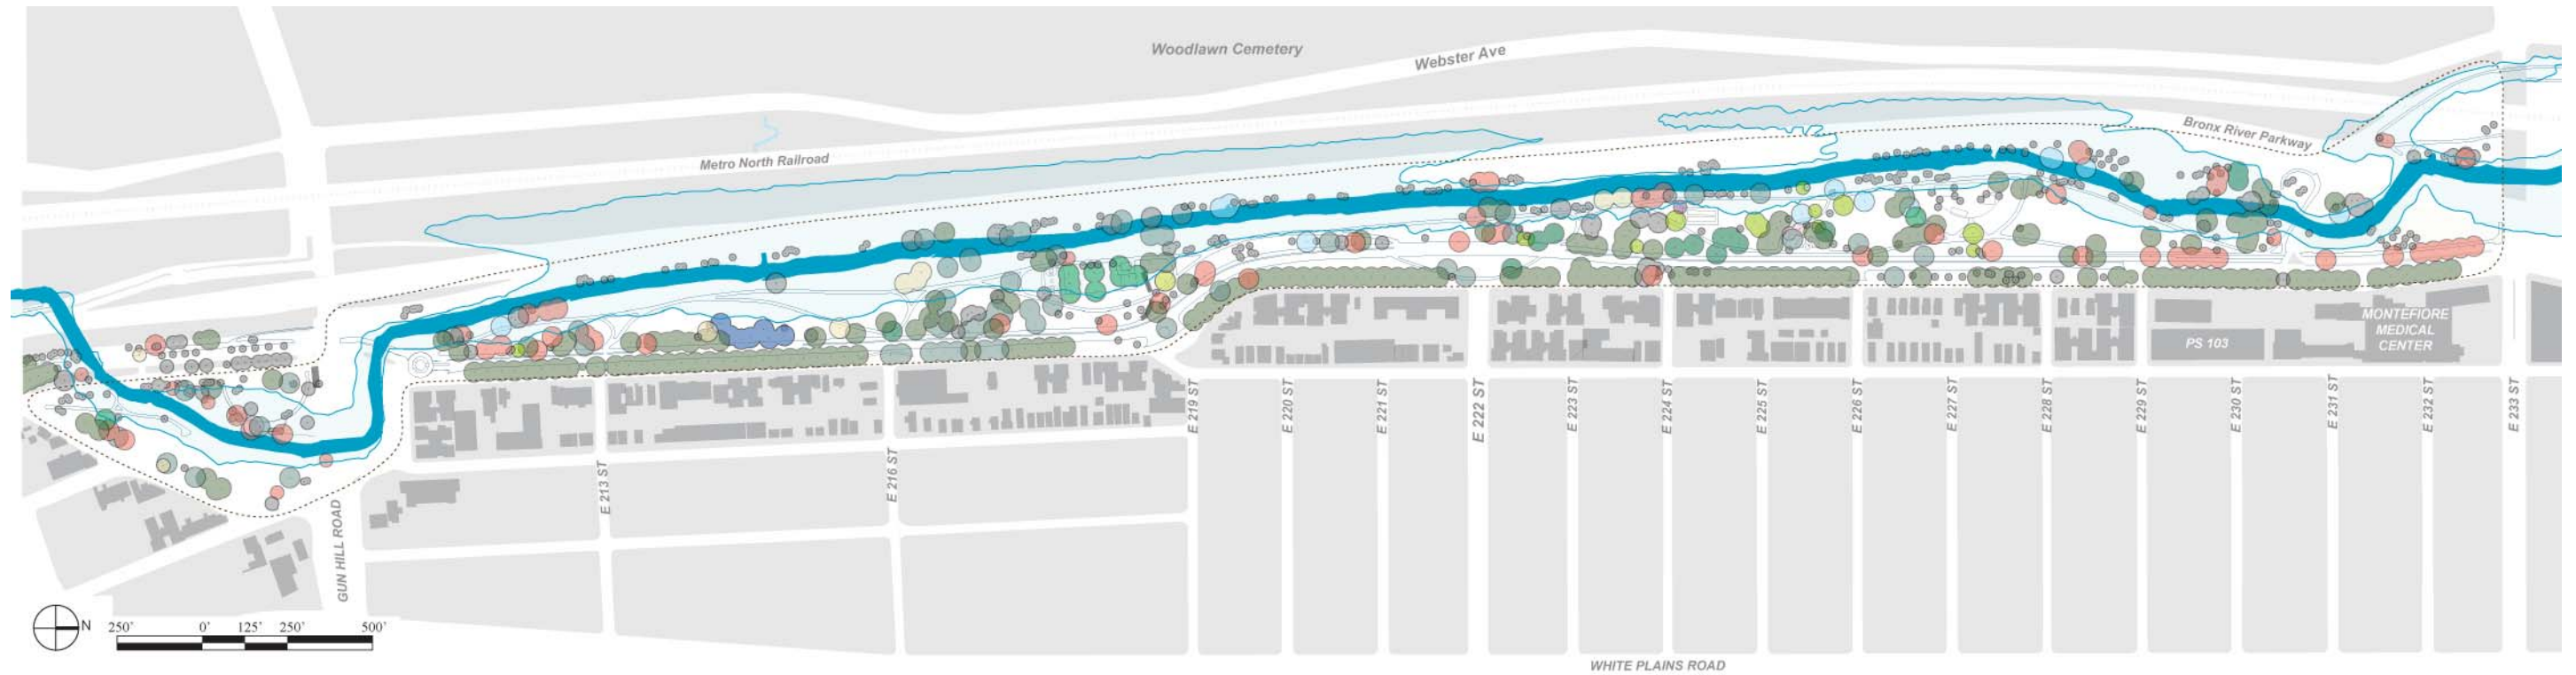
### Canopy Vegetation

Woody vegetation growth rate analysis was conducted to determine the approximate size of species that are believed to be alive in the park today as represented in the last completed survey (NYCDPR, 1990)

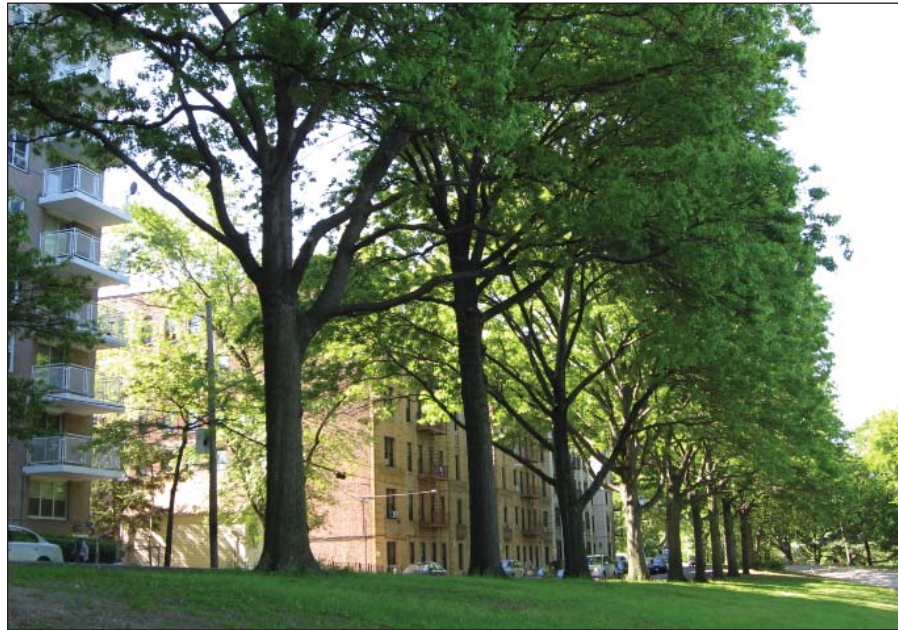
Row of historic Oaks in southern section of Shoelace Park

There are currently two dominant landscape typologies within the park, each with their own visual qualities and maintenance regimes. The first landscape type is Pastoral, established during the creation of the historic Bronx River Parkway from 1907 to 1925. The pastoral landscape type became prevalent as parkways were built throughout America, and over time has become ingrained as a distinguished twentieth-century vernacular landscape. The line of majestic Oak trees along the historic parkway road-bed stands as a reminder of the parkway project and its distinctive historic landscape. Mature trees, many with calipers up to 48" diameter at breast height (dbh), are located in a less formal arrangement within generous lawn panels. Fewer large trees are found closer to the river's edge. This pastoral landscape typology dominates the park at higher elevations.

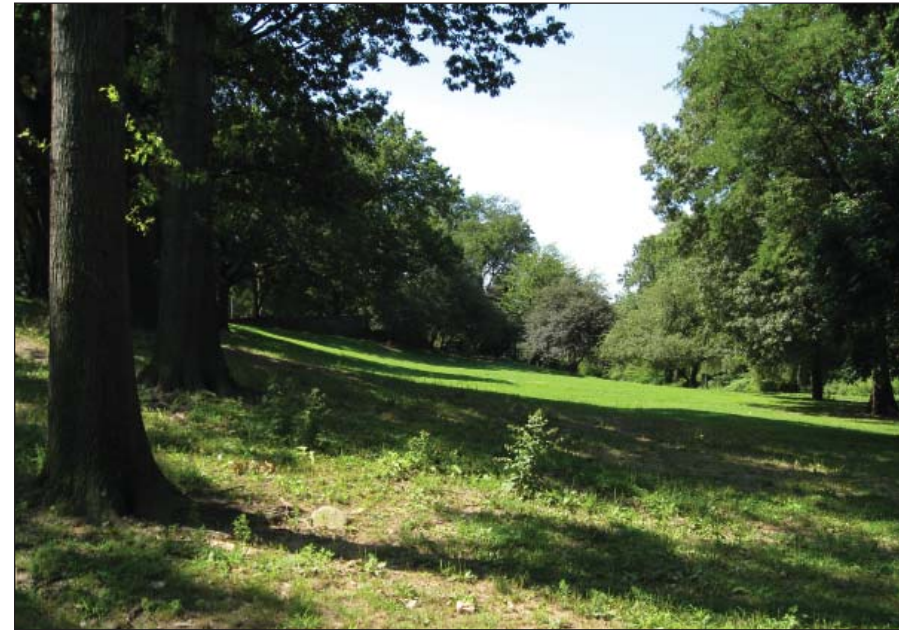
Pastoral lawn area
