### 100-year Flooplain

## Floodplain Resource Management

### Vegetation

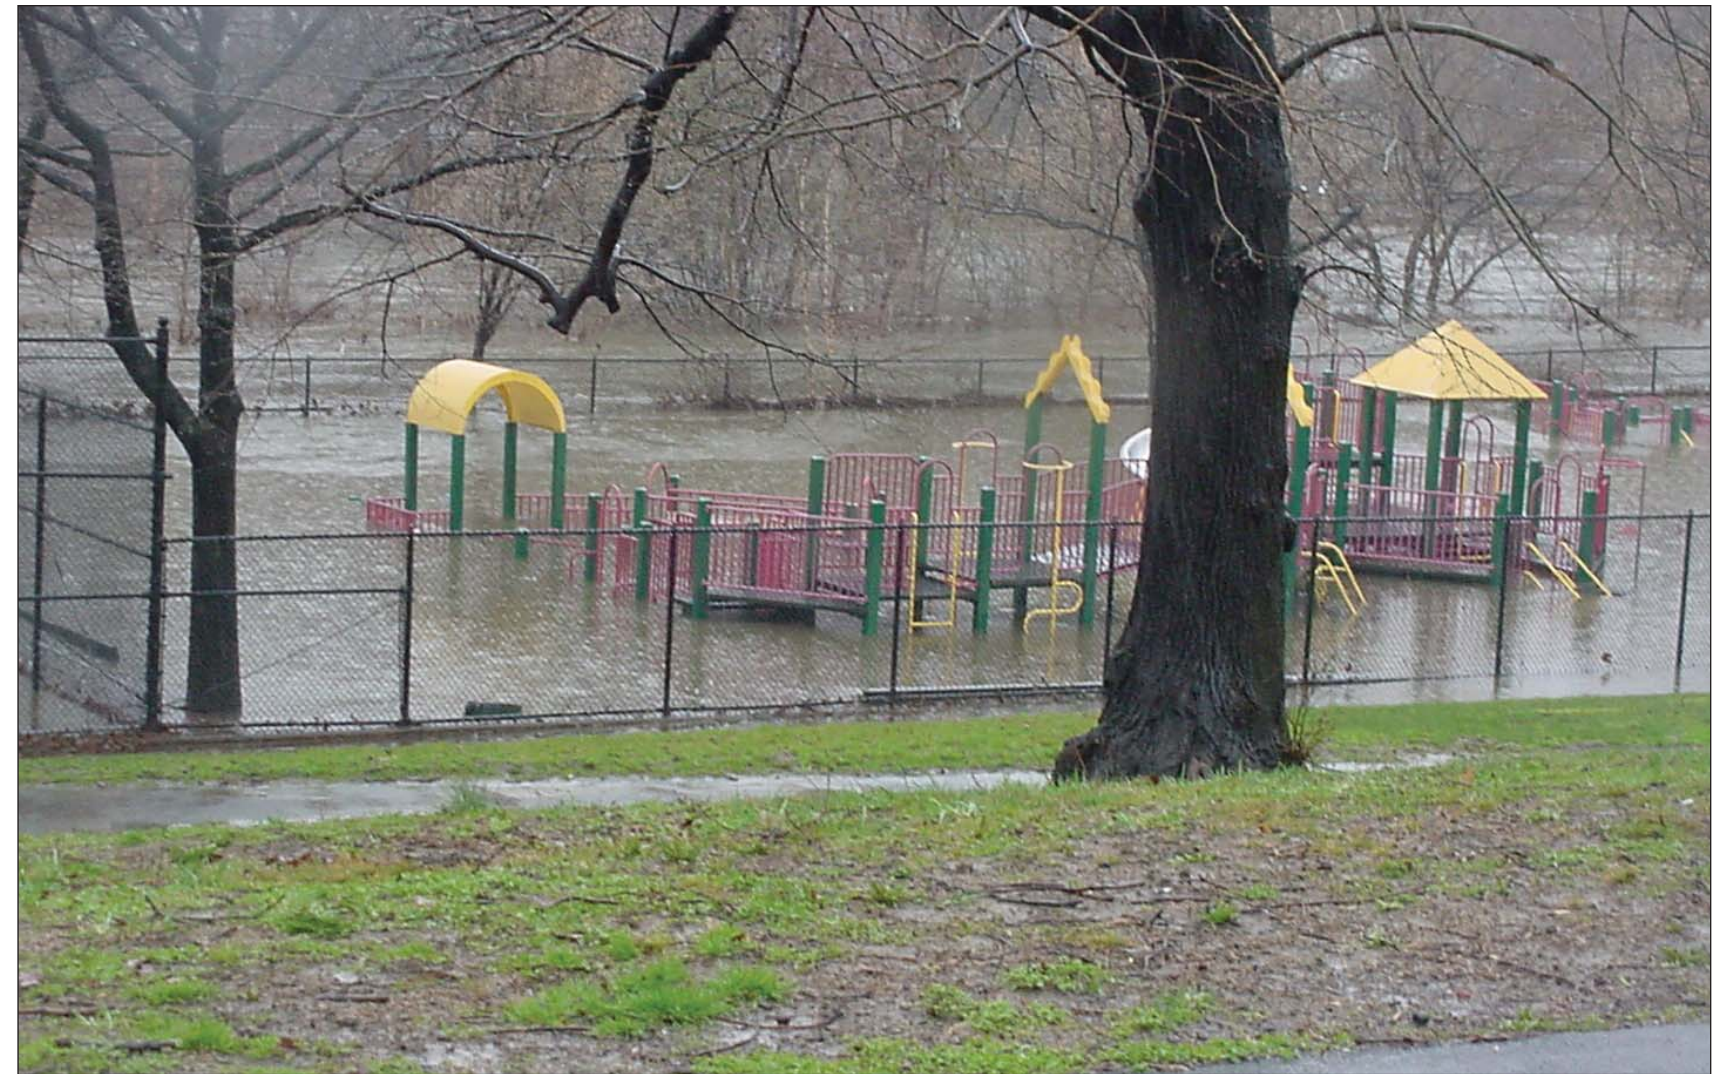
Olinville Playground in Flood, Spring 2007
