**BRONX RIVER
ALLIANCE**

**ECOLOGICAL
RESTORATION
AND
MANAGEMENT
PLAN**

MAY 2006

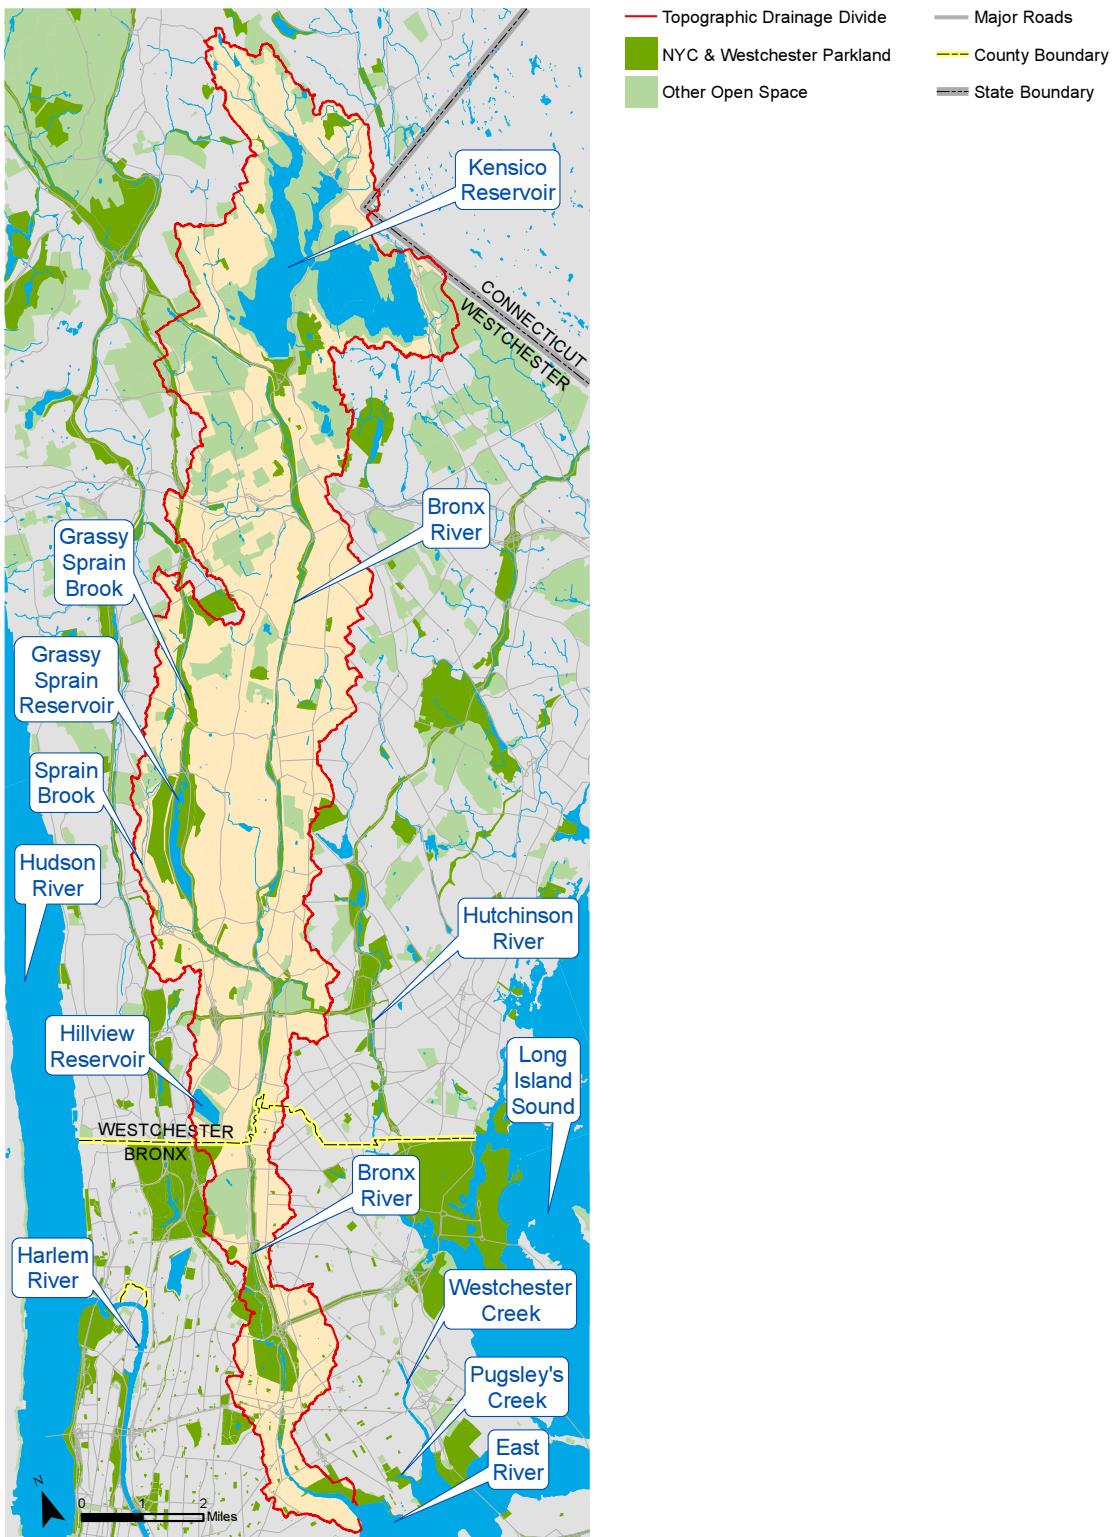
FIGURE II.1:
THE BRONX RIVER WATERSHED

The topographic drainage divide (red line) encompasses the 56 square mile Bronx River watershed, or region of land where water from rain or snowmelt drains downhill into the river. The drainage basin includes both the streams and rivers that convey the water as well as the land surfaces from which water drains into those channels.

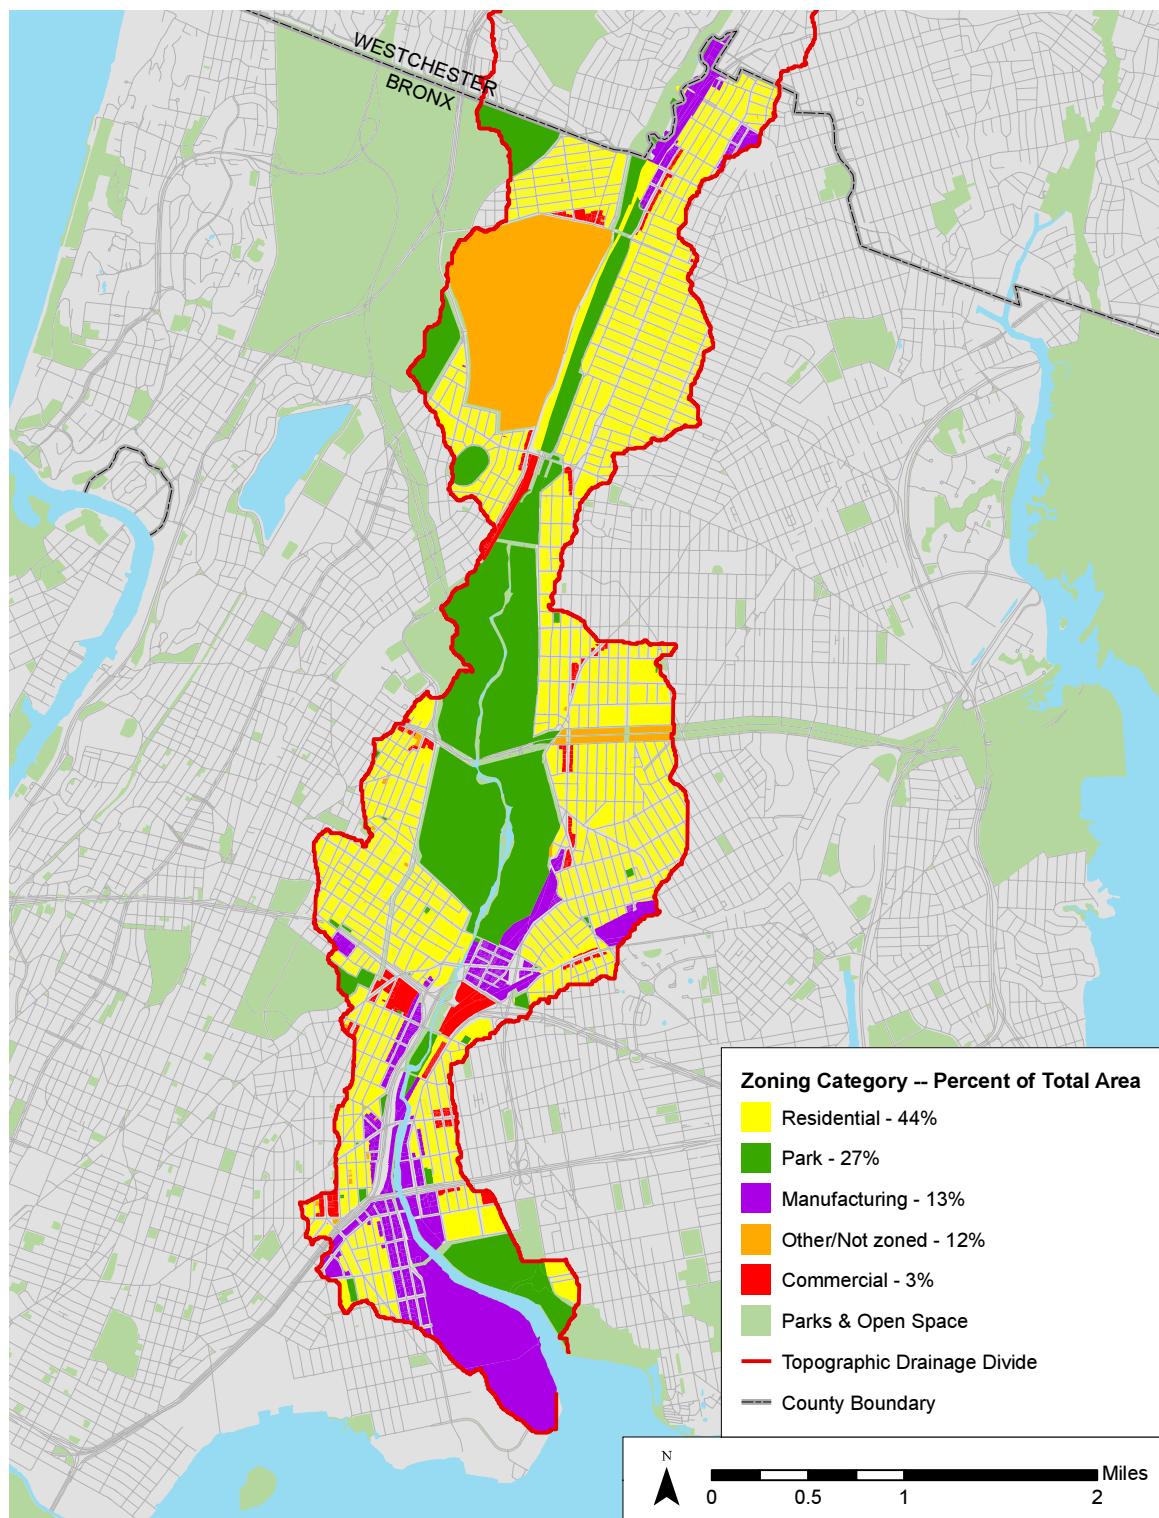
FIGURE II.2:
ZONING IN THE BRONX RIVER WATERSHED

This zoning map gives a characterization of the watershed in the Bronx. From north to south it transitions to increasingly dense urban development, both residential and industrial and is dominated by impervious surfaces such as roads, rooftops and parking lots.

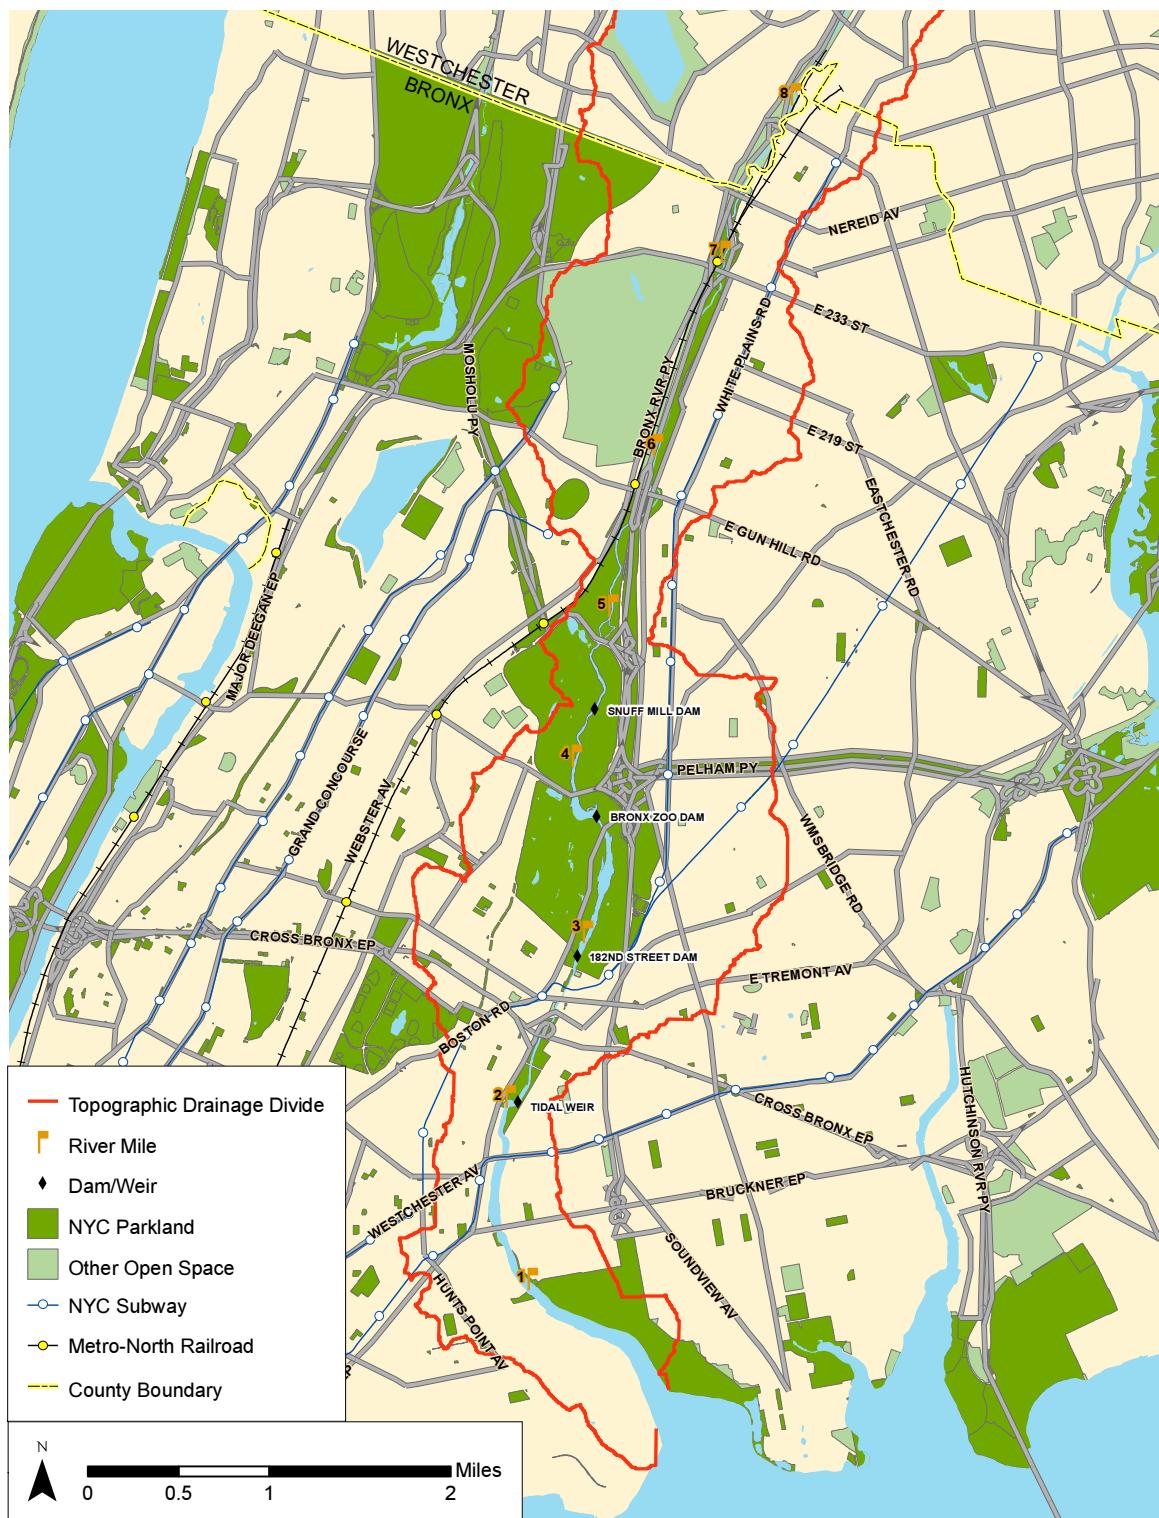
FIGURE II.3:

The area bounded by the red line is the Bronx River Watershed, or all of the land that drains to the river. The river's watershed in the Bronx is the area addressed by this plan.

In order to provide detailed descriptions of the conditions and opportunities for restoration work, the Bronx portion of the river has been divided into four sections based on broad land-use and physical characteristics {FIGURE 11.3}. From north to south these are: the Parkland Section (3.5 miles), the New York Botanical Garden/Zoo Section (1.8 river miles), the West Farms Section (0.4 miles) and the Estuary Section (2.5 miles).

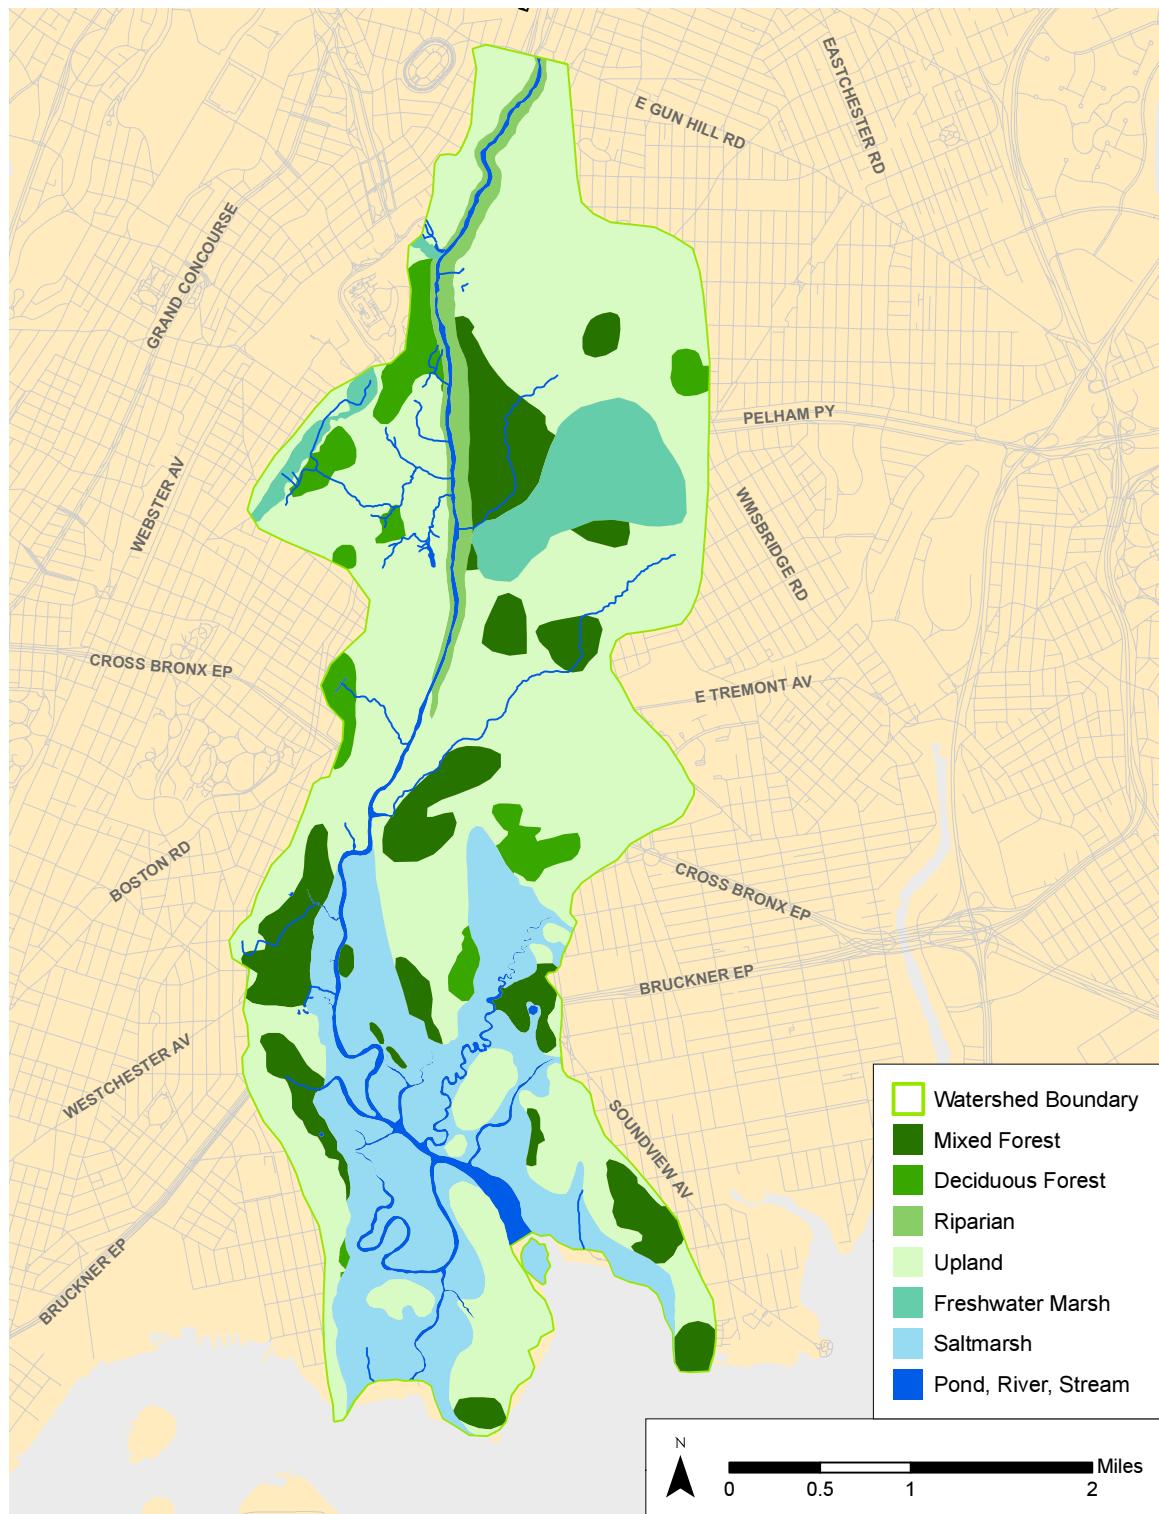
FIGURE II.7:
HISTORICAL BRONX RIVER (1781 – 1851)

Prior to widespread settlement and development, the Bronx River was much more sinuous and its watershed dominated by natural systems like forests, wetlands, and salt marshes.

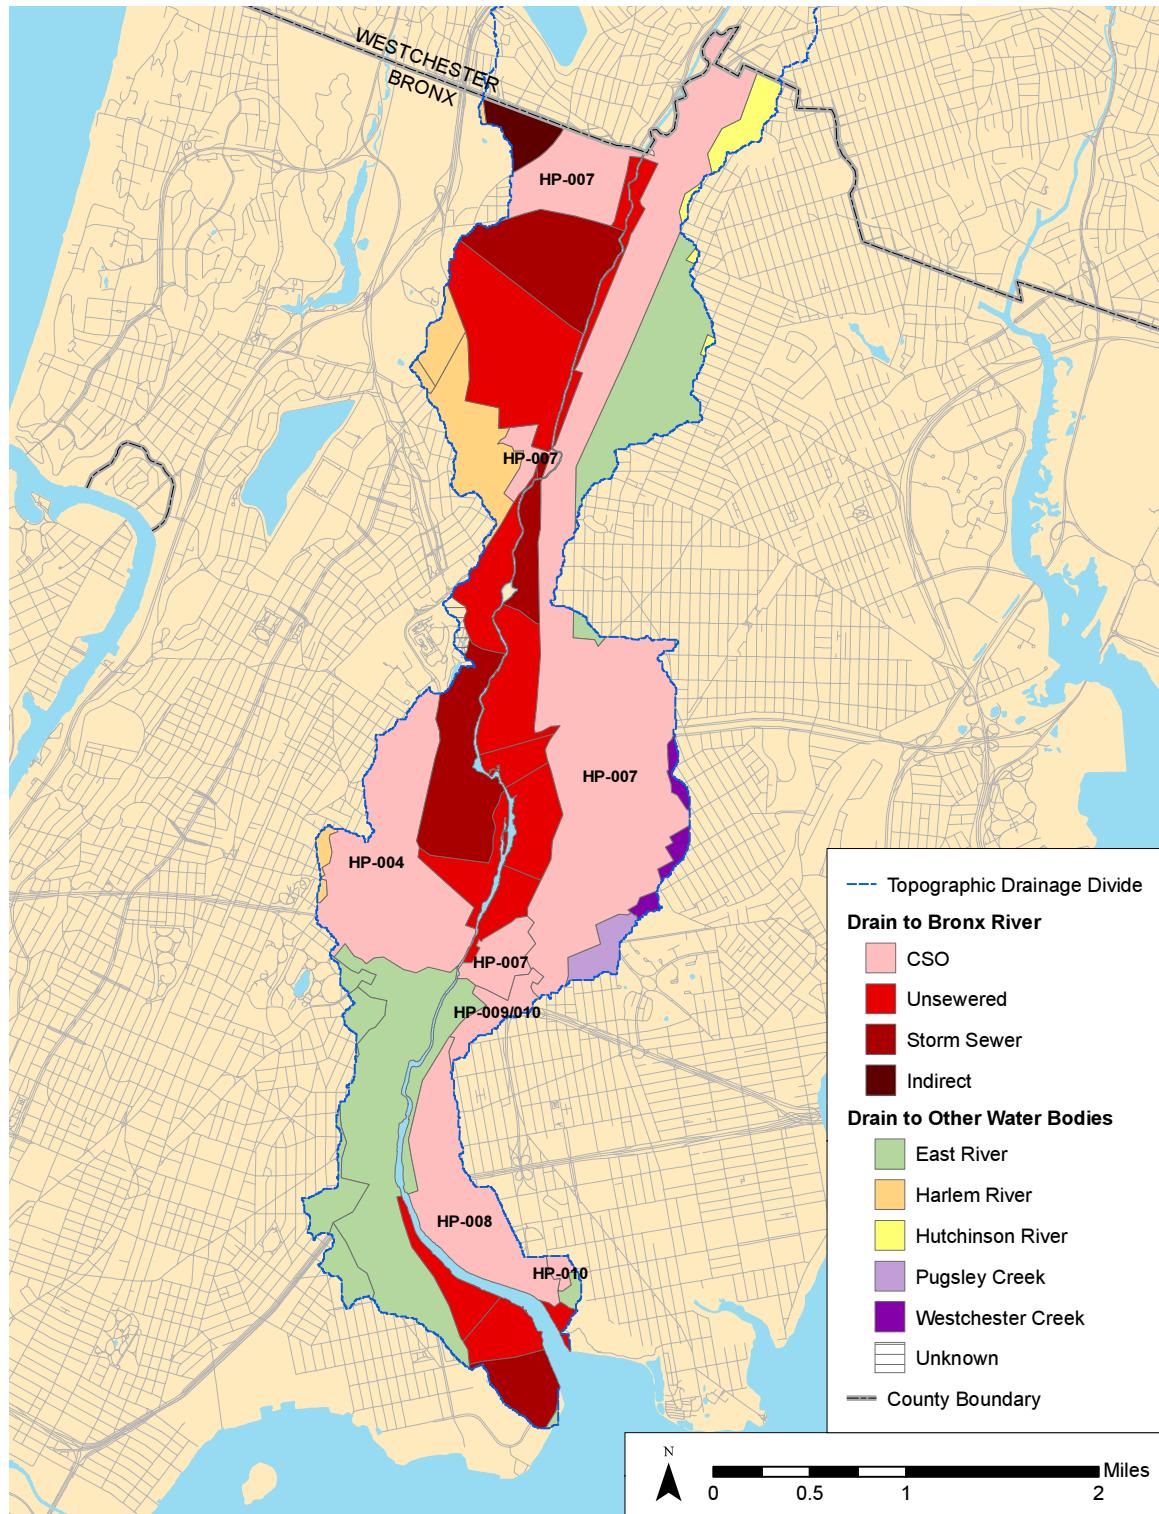
FIGURE III.1:
SEWER SHEDS WITHIN THE BRONX RIVER TOPOGRAPHIC DRAINAGE DIVIDE

In 3200 acres of the 4500 acre Bronx River watershed in the Bronx, storm water is captured and piped to water treatment plants located outside of the watershed. This map shows how the watershed is divided into smaller "sewersheds".

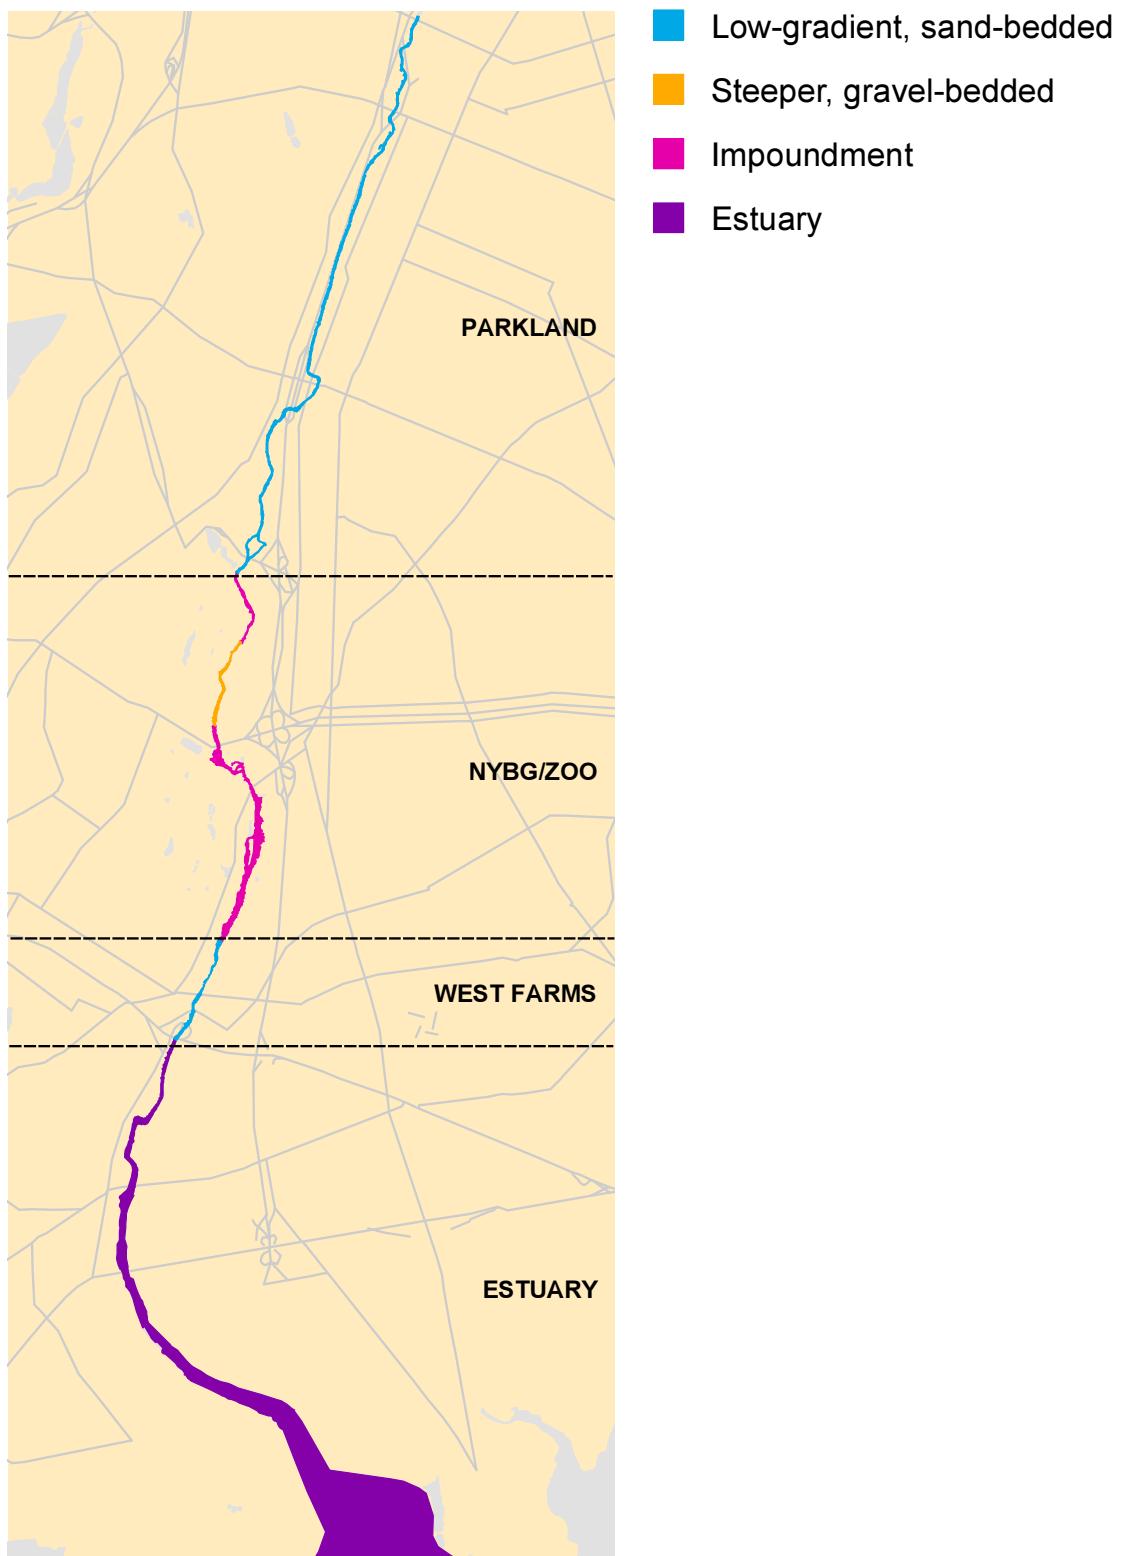
FIGURE III.2:
BRONX RIVER MORPHOLOGY

This figure shows the locations of the different channel types described in the Channel Morphology and In-stream Habitat section. Characterizations of river reaches describe physical and habitat conditions as well as how the reach may respond to disturbance, protection or restoration.

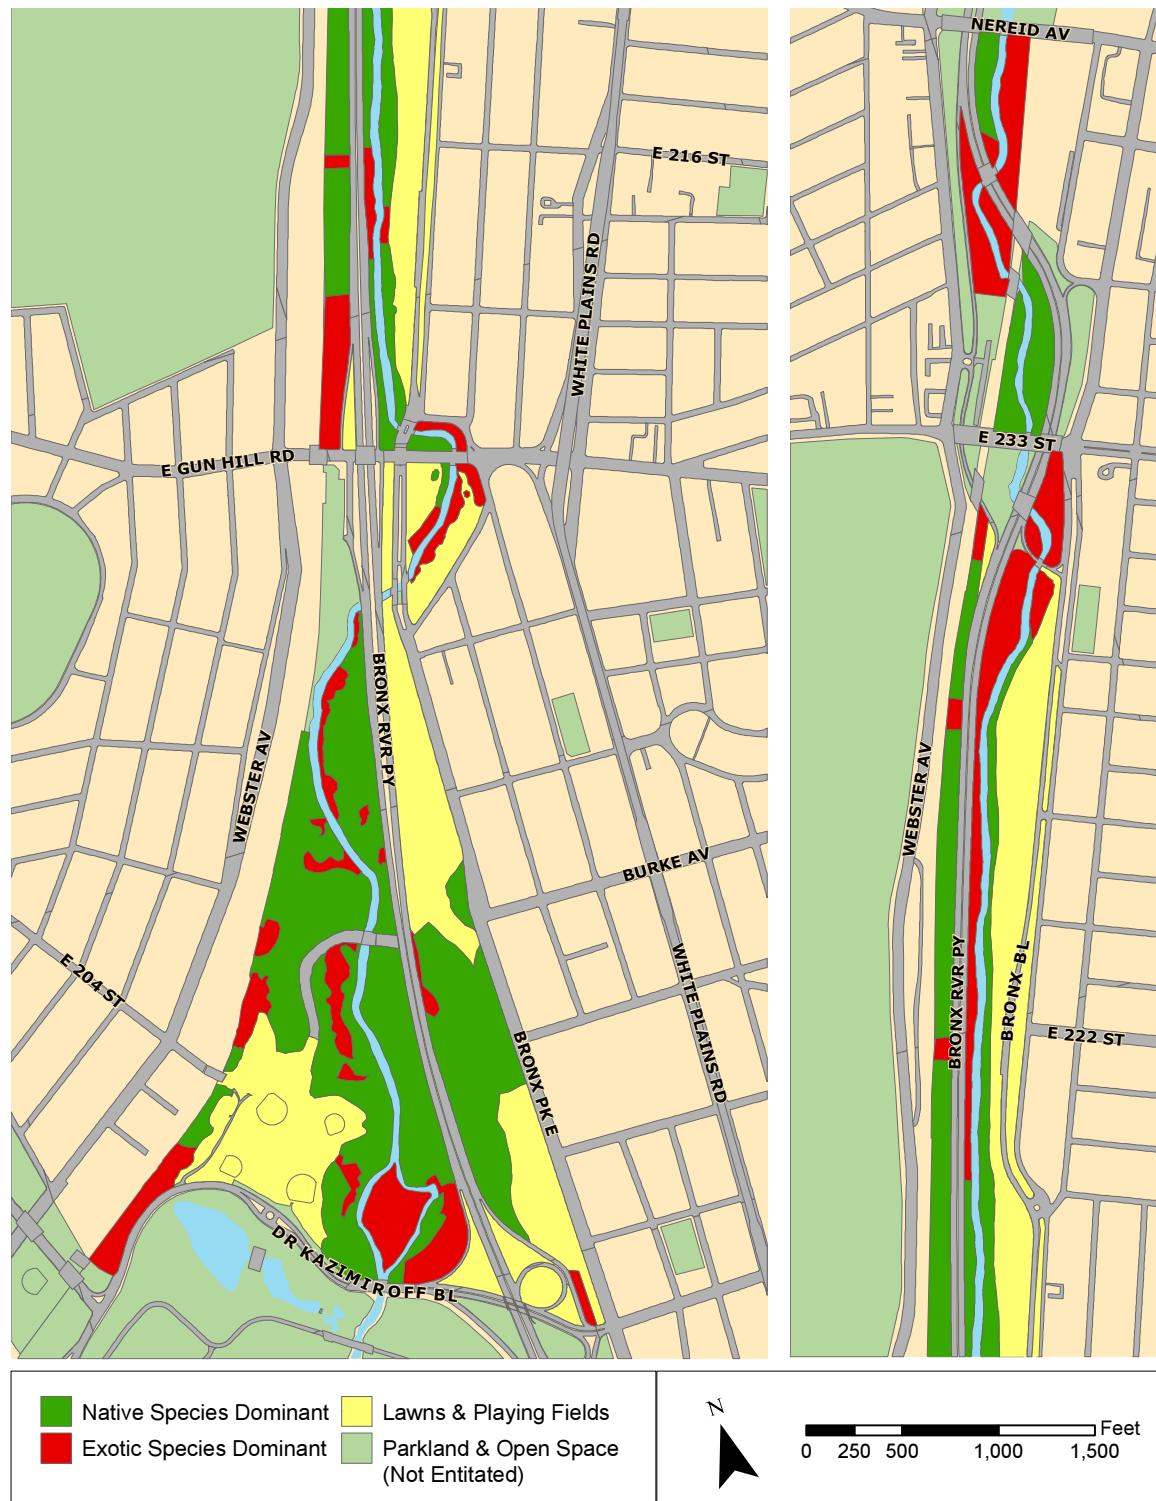
DISTRIBUTION OF EXOTIC VEGETATION IN THE BRONX RIVER FOREST + SHOELACE PARK

Invasive species are so reproductively successful and aggressive that they can dominate an area, often to the point of becoming a monoculture. They interfere seriously with the natural functioning and diversity of the system where they become established. Some debate exists over which exotic species are truly invasive.

Area boundaries were determined by entitation, a process of delineating ecological communities based on species composition and structure. NRG staff entitated the Bronx River Forest and Shoelace Park in the summer of 2005. Areas are estimates, and are intended for illustrative use only.

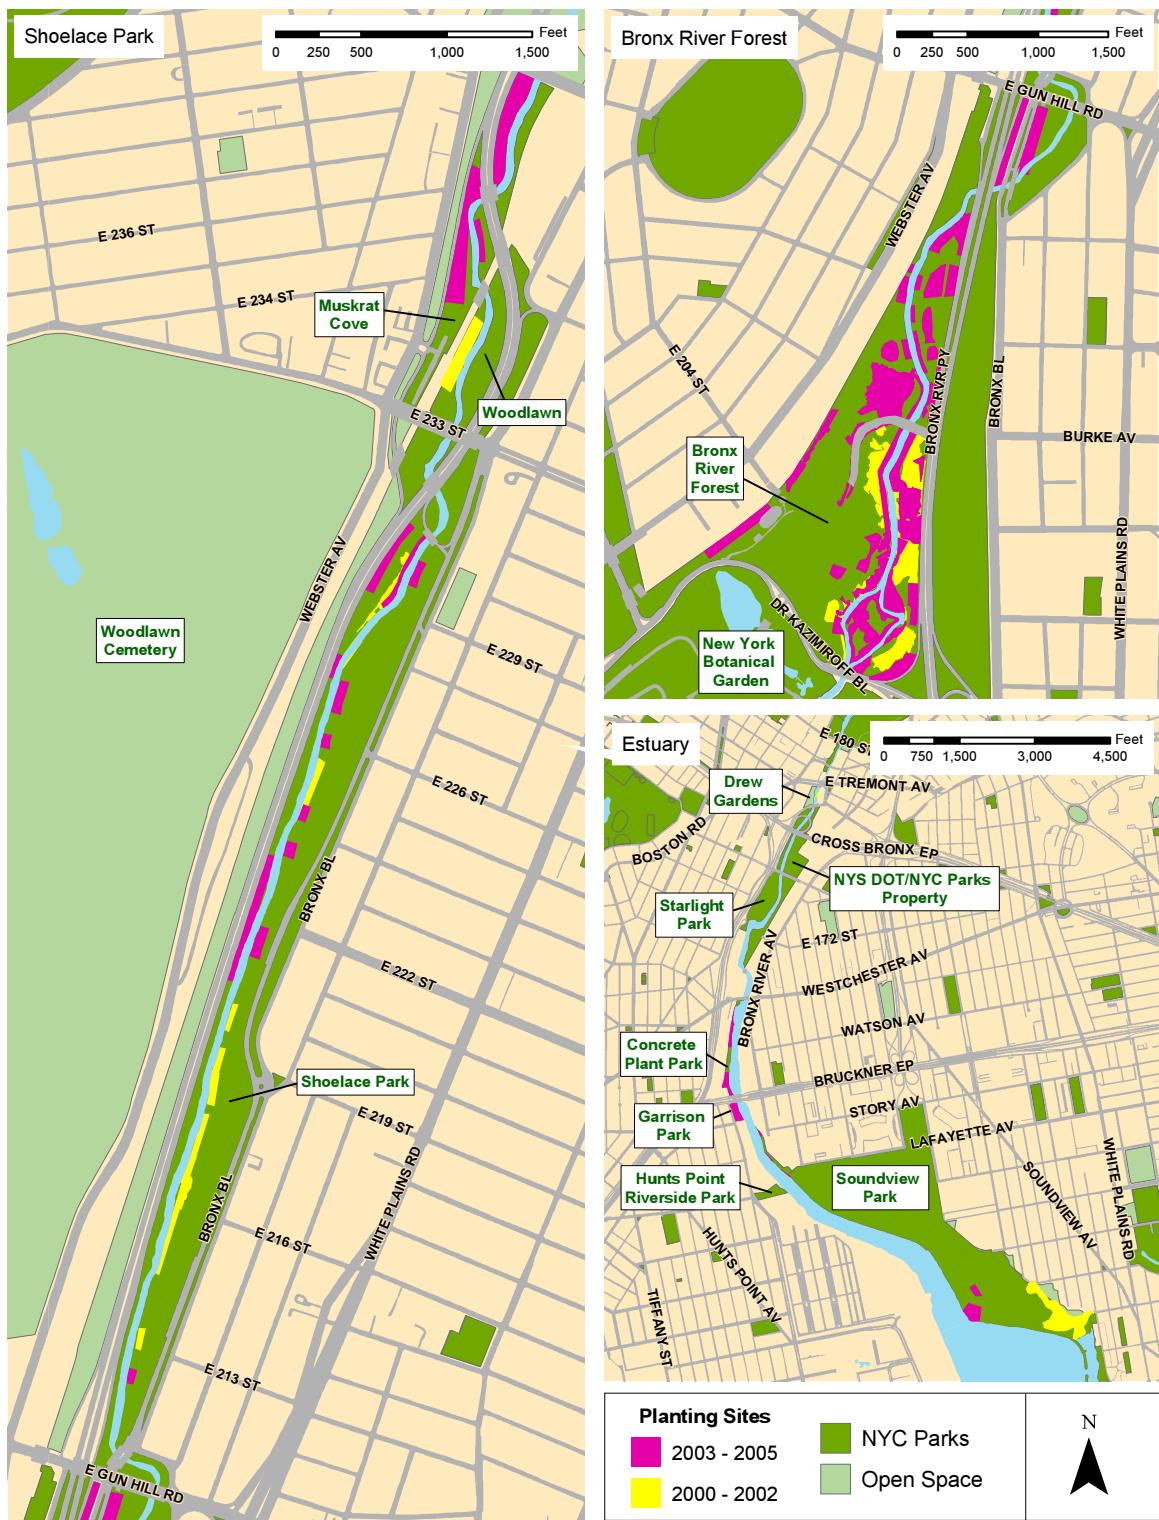
FIGURE III.4:
BRONX RIVER PLANTING + RESTORATION SITES

Since 2000, the Bronx River Alliance and NRG have implemented numerous restoration projects to improve the river's health. This map shows a general distribution of where their work has taken place and when it was done.

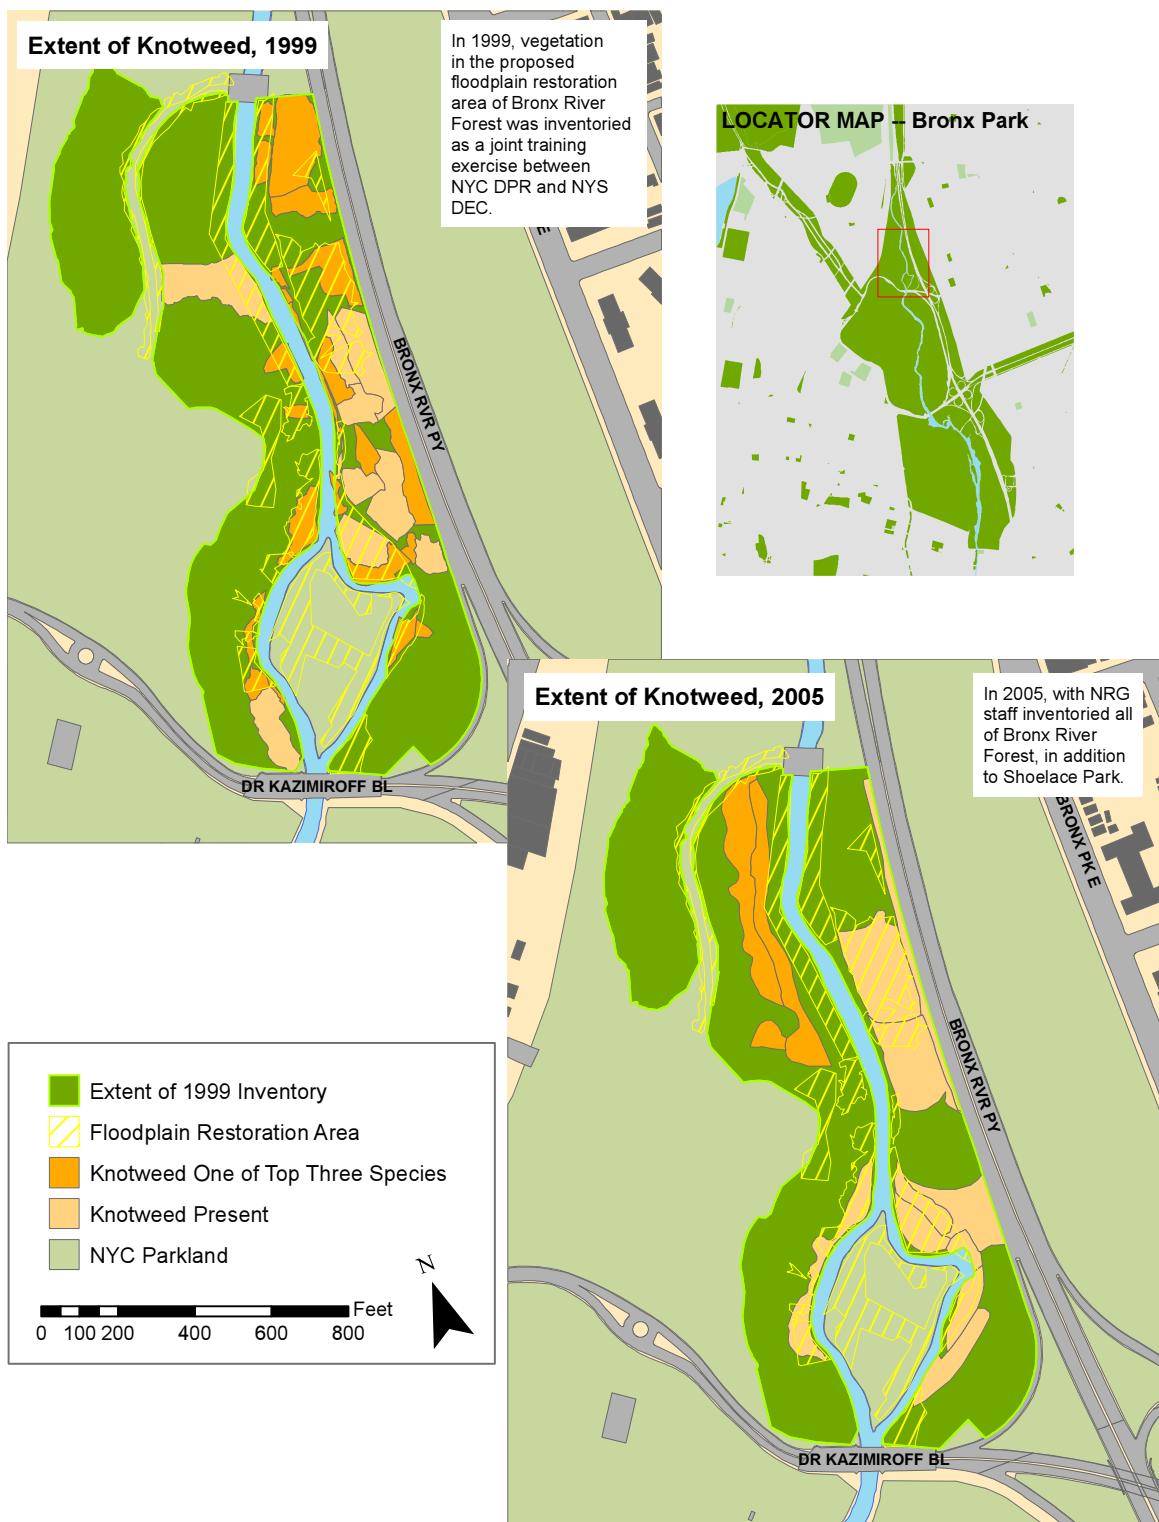
DISTRIBUTION OF JAPANESE KNOTWEED IN BRONX RIVER FOREST

Vegetation inventories in the Bronx River Forest were completed using entititation, a process of identifying and describing discrete vegetation units ("entities") based on species composition and structure. A 2005 restoration project reduced the amount of Japanese knotweed, but ongoing work is necessary to keep this extremely invasive plant under control. The Alliance Conservation Crew and NRG will continue to restore and maintain the Bronx River Forest. Due to these efforts, the distribution of knotweed can change on a short timescale.

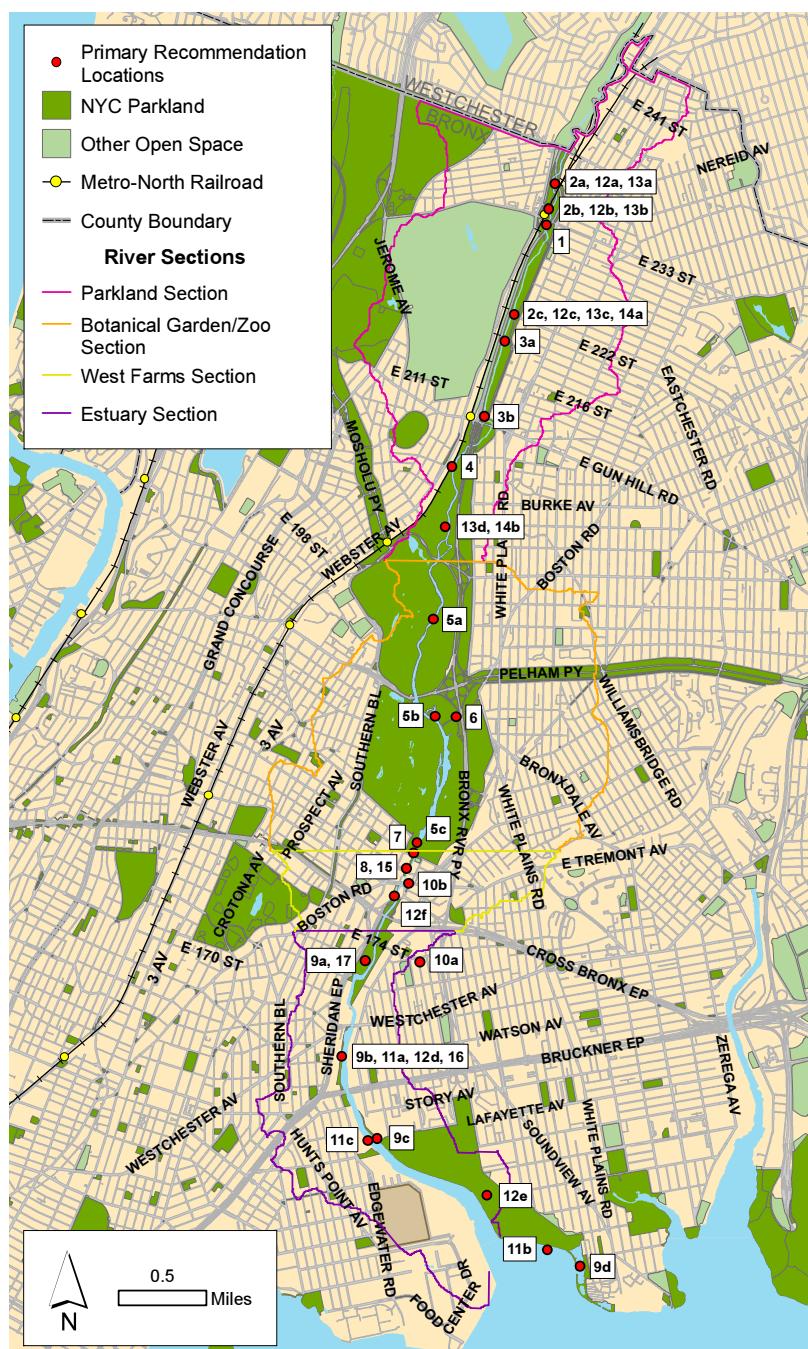
FIGURE V.1:
PRIMARY RECOMMENDATIONS

Numbered locations on this map correspond to primary recommendations listed in Table V.2. Actions listed as watershed-wide are those that should be pursued wherever possible throughout the watershed.

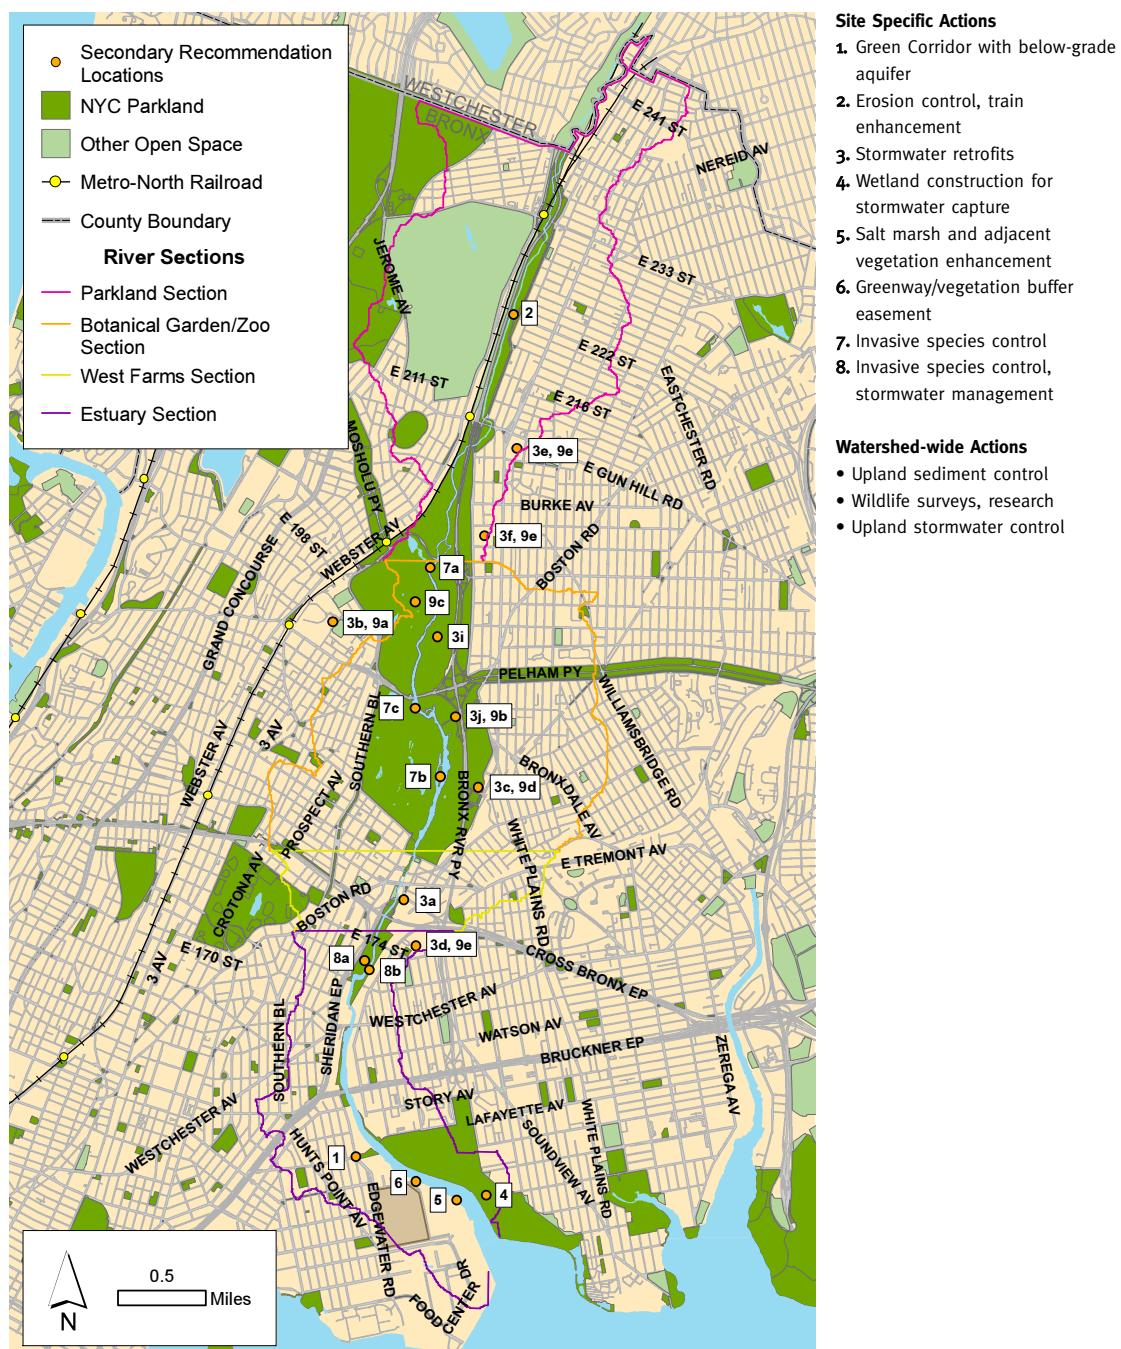
FIGURE V.2:
SECONDARY RECOMMENDATIONS

Numbered locations on this map correspond to secondary recommendations listed in Table V.3. Actions listed as watershed-wide are those that should be pursued throughout the watershed.
