# **Bronx River Corridor Study and Management Plan for Westchester County, NY – Volume I**

Prepared for  
Westchester County Soil and Water Conservation District  
and  
Westchester County Department of Planning  
White Plains, NY

Prepared by  
John Field  
Field Geology Services  
Portland, ME

July 2019

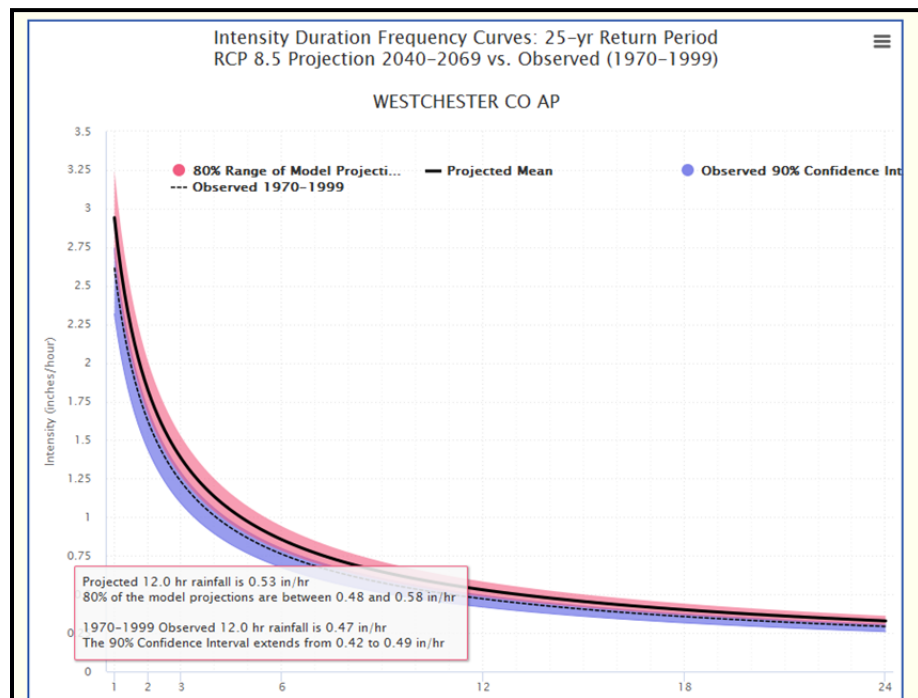
Figure 6. Projected increase in average rainfall intensities.

The types of rainstorms the Bronx River Corridor experiences have also changed over the last several decades, a trend that is expected to continue (Figure 6). The projected mean of rainfall intensity (solid line) is expected to increase over observed

rainfall intensity (1970-1999) during larger and infrequent rainfall events. Figure 6 shows the projected average rainfall intensity for a 25-year return interval rainfall event (probability of occurring is 0.05 in any given year) with a duration lasting 1 hour to 24 hours. The amount of rainfall depth occurring during intense rainstorms will increase notably over the next 50 years with higher percentages of the annual rainfall falling during intense storms between short seasonal droughts.

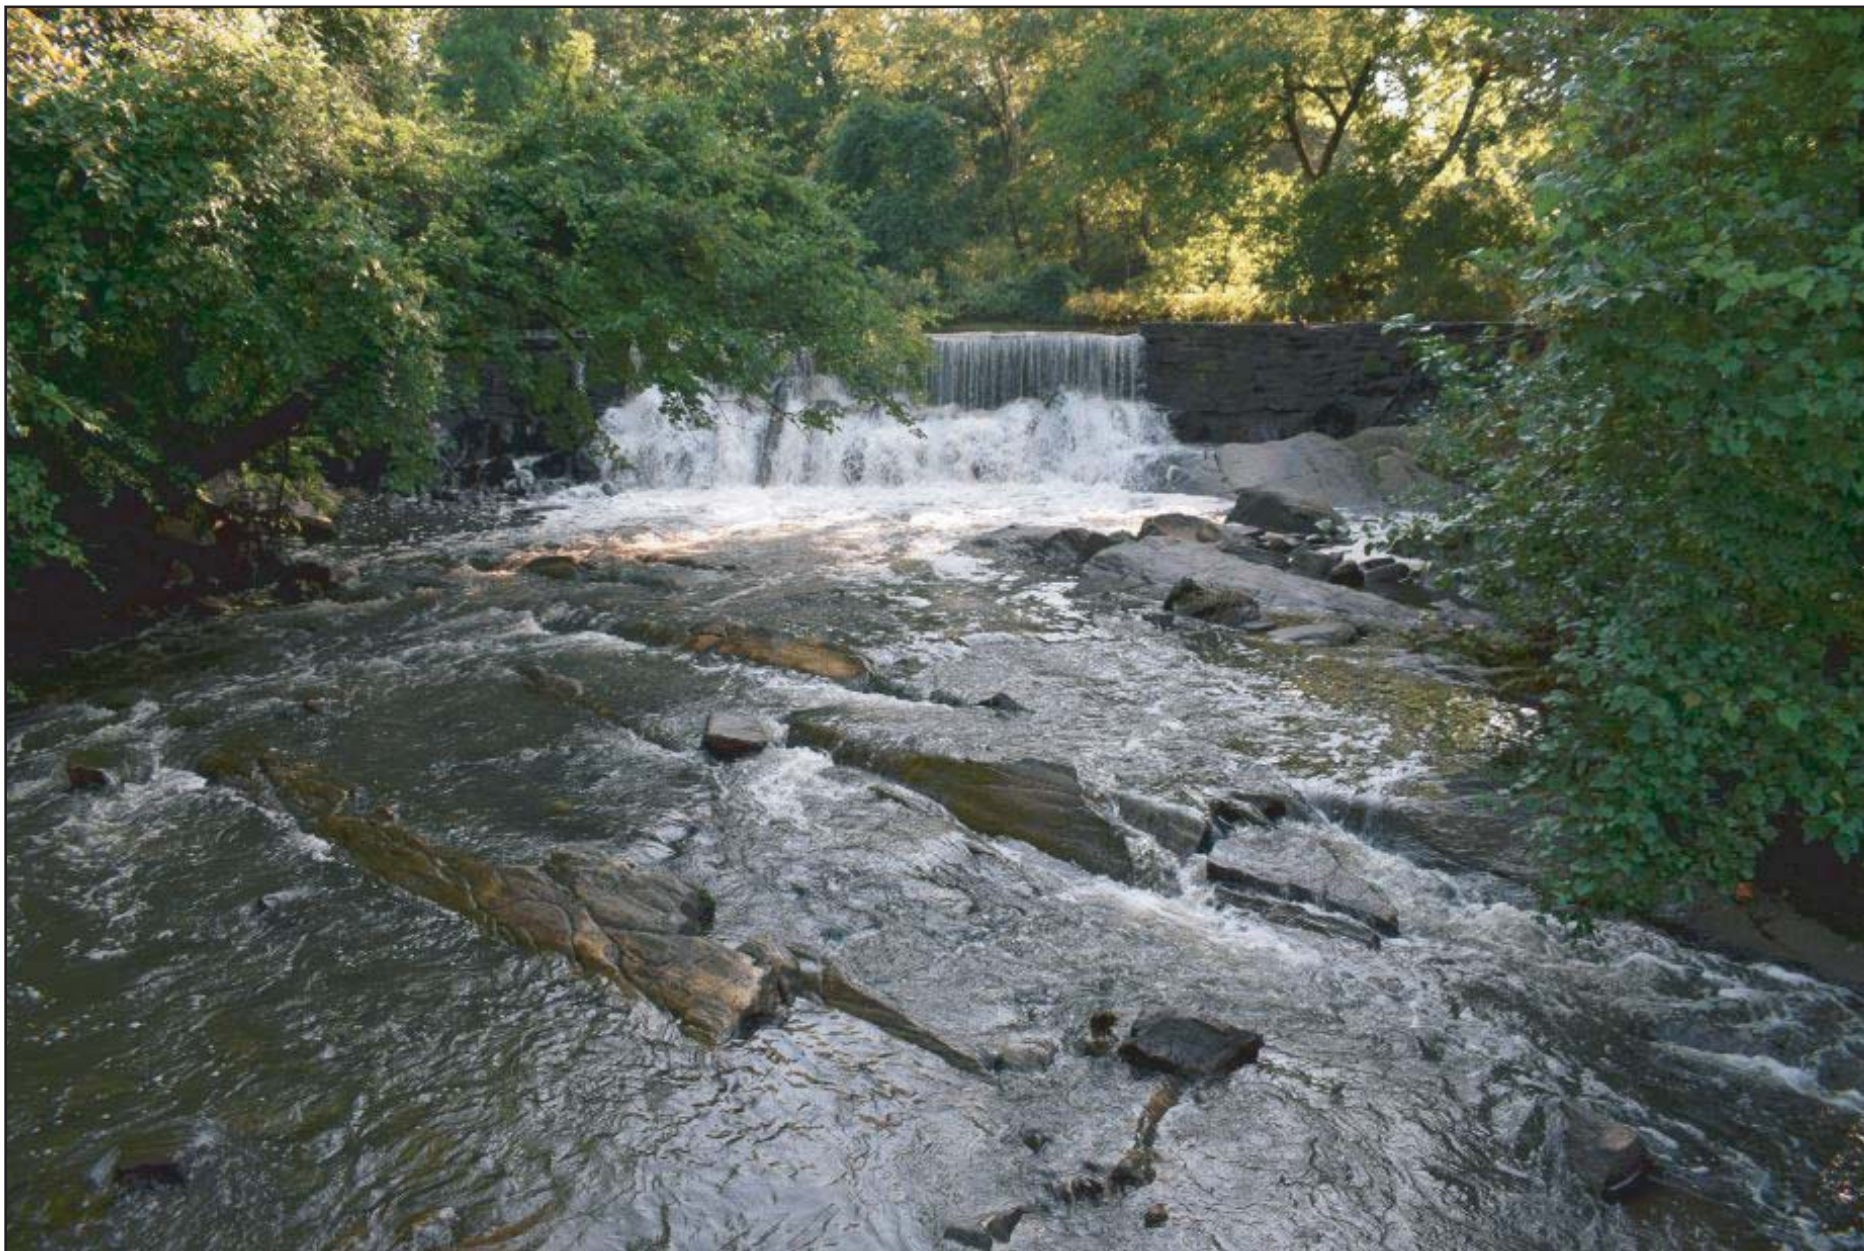
Figure 3. Low natural falls in Scarsdale, N.Y. atop of which was built a low head check dam.

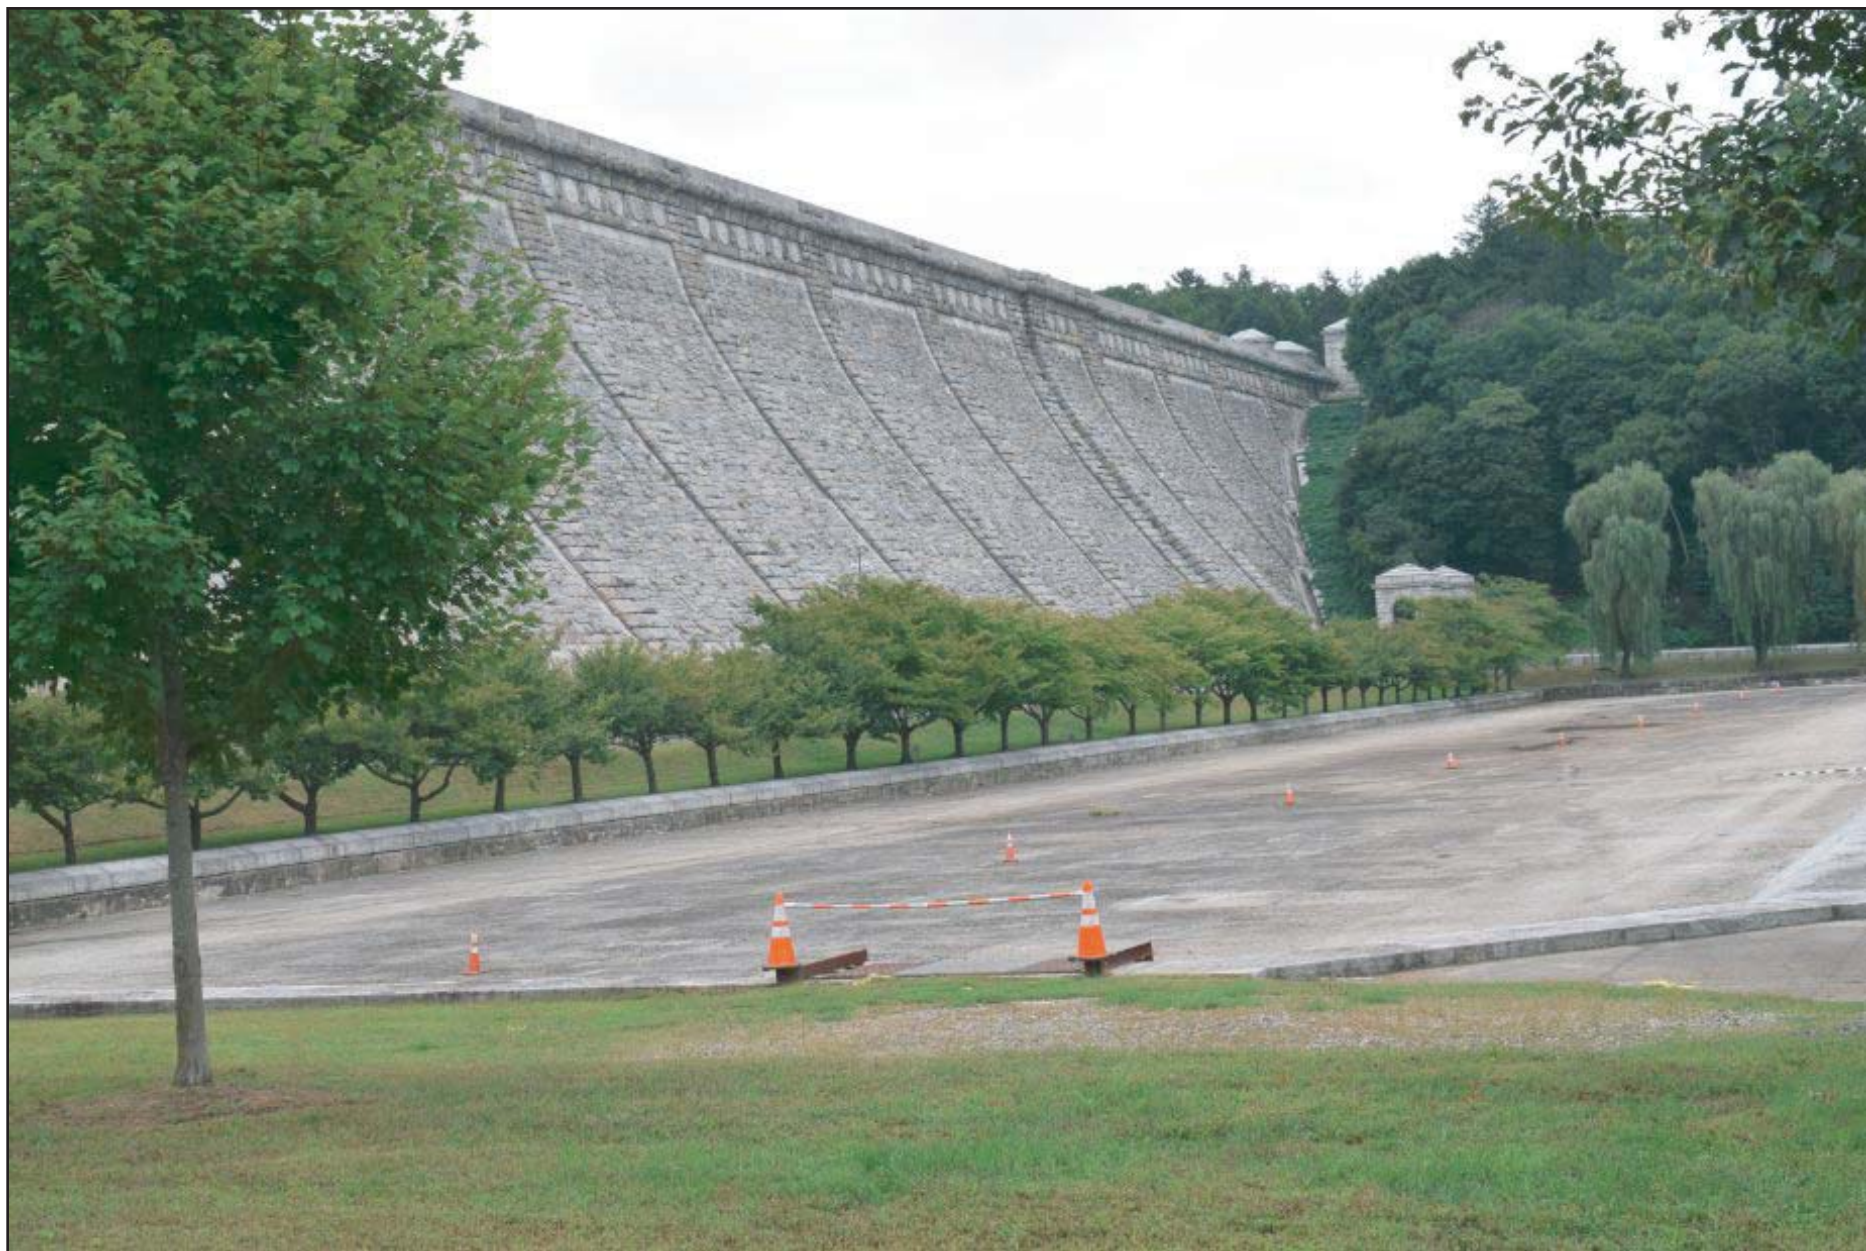
Figure 8. Kensico Dam at upstream end of Bronx River in Valhalla, N.Y.

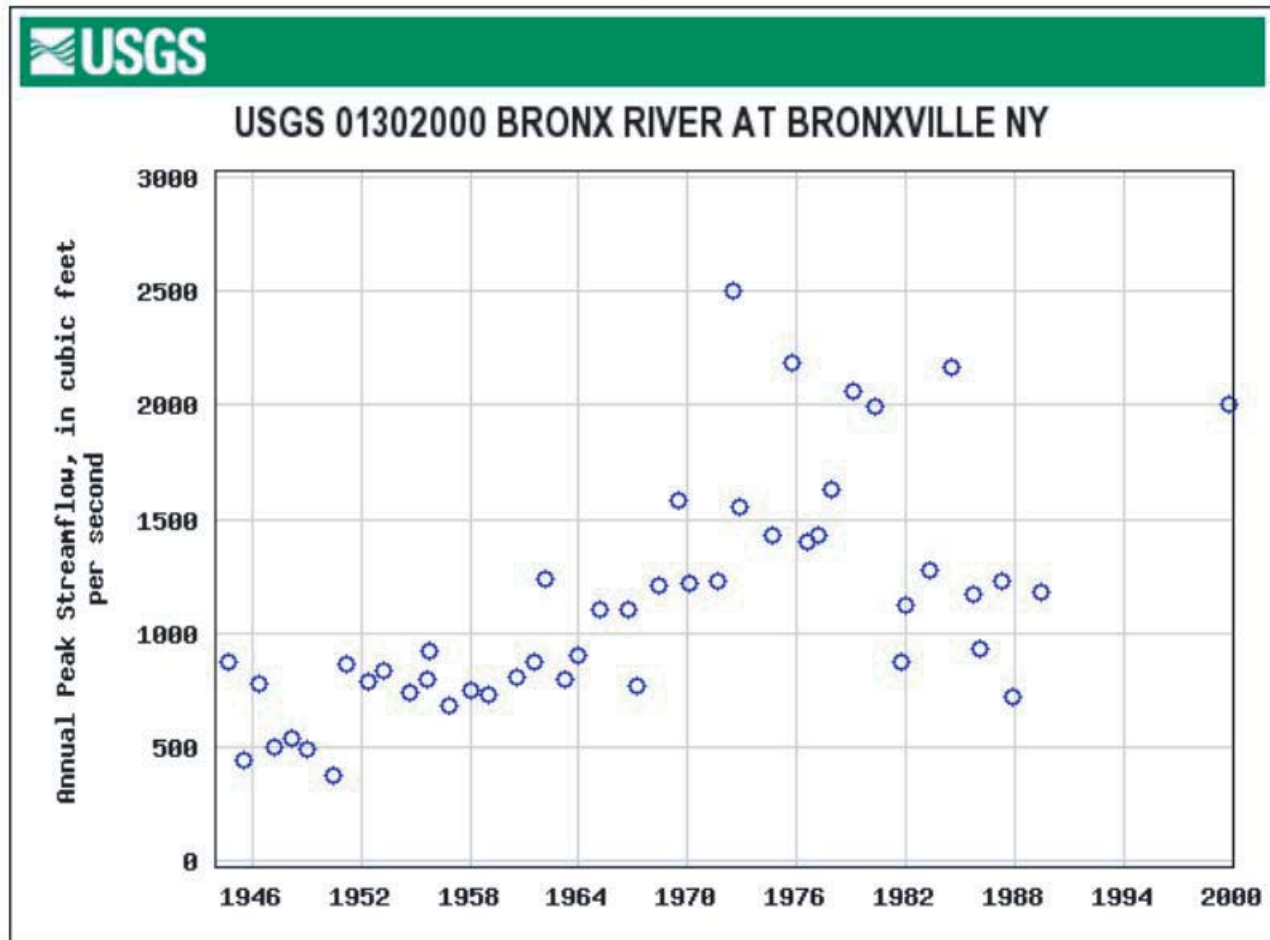
Figure 9. USGS gauge record from Bronxville, N.Y.

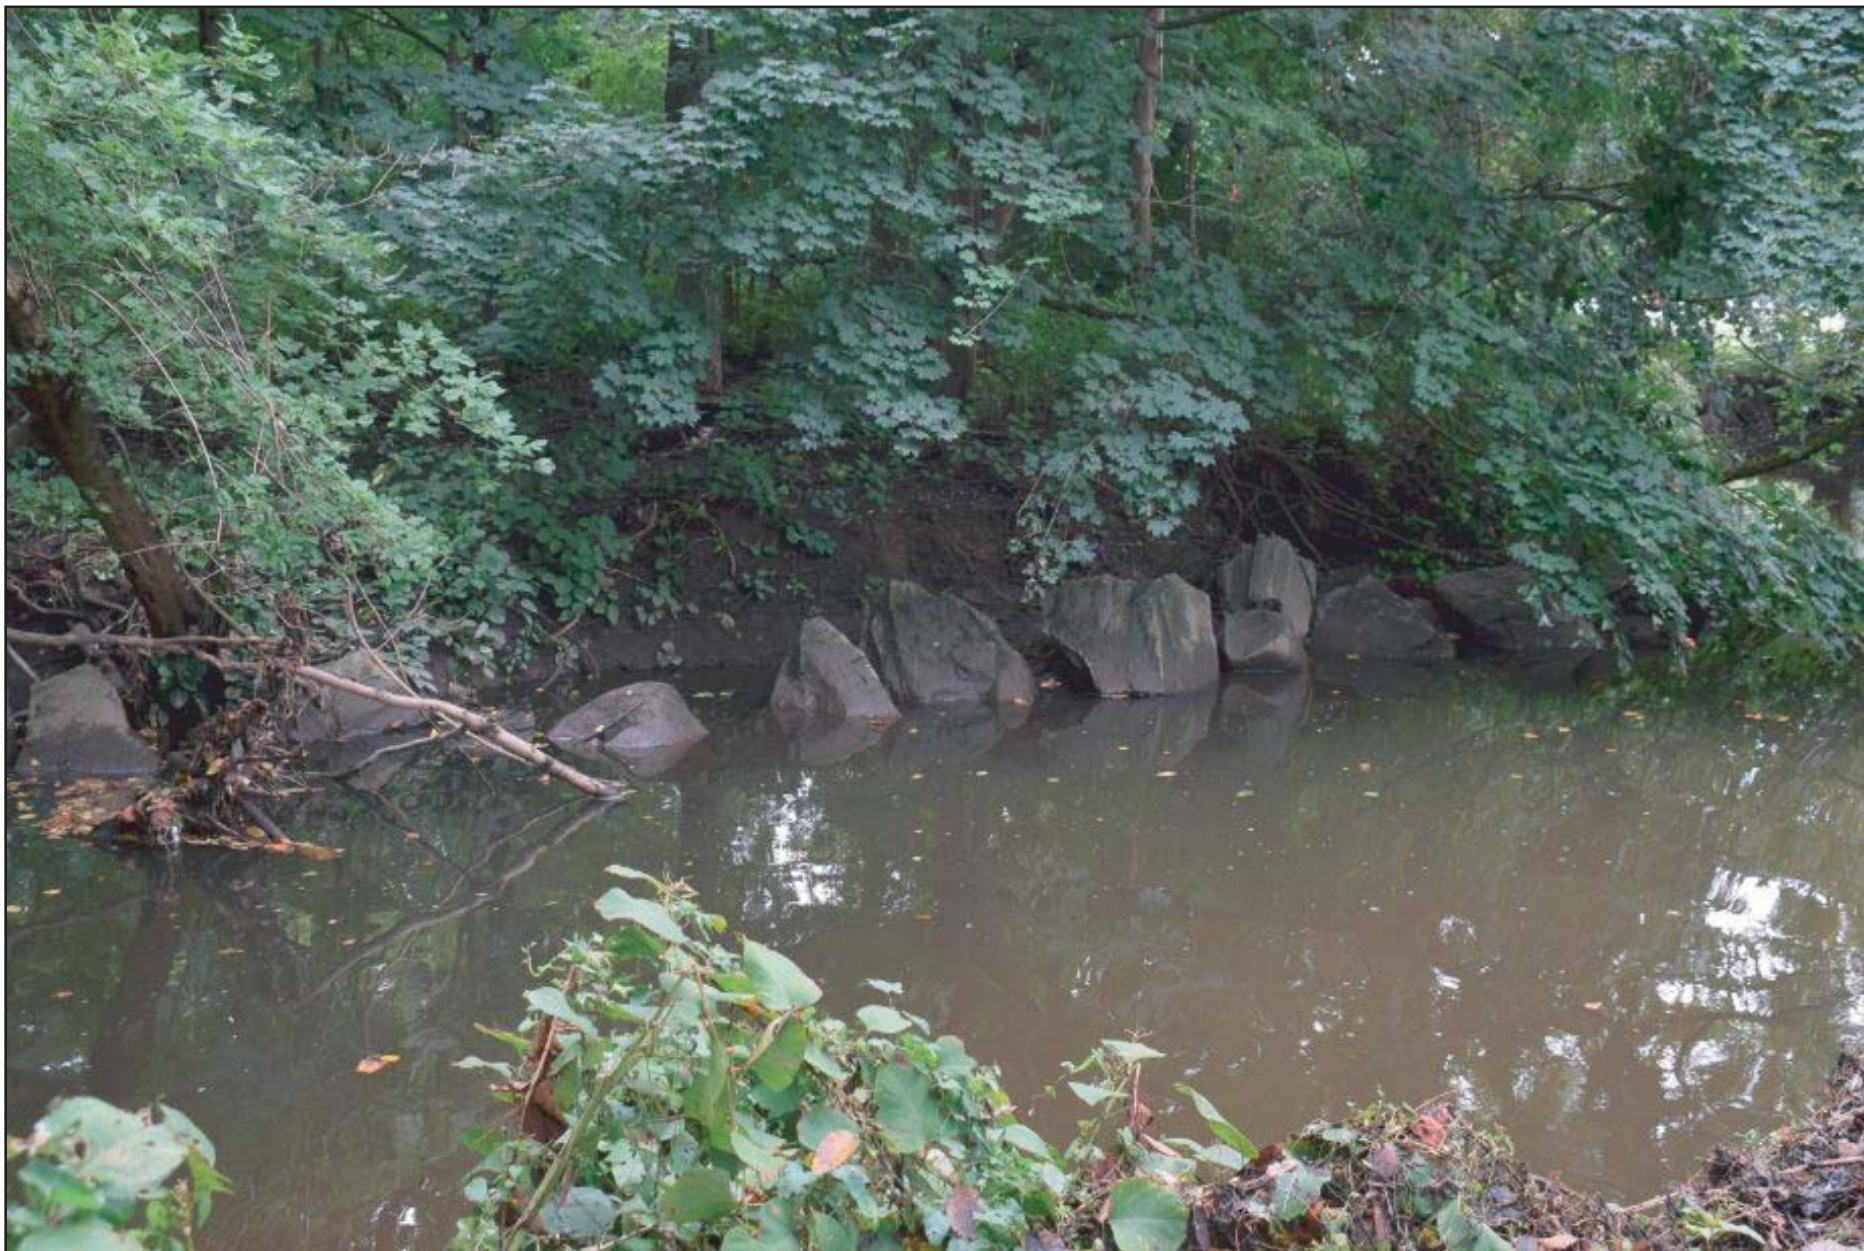
Figure 21. Erosion attacking a bank where the armor has failed on the Bronx River.

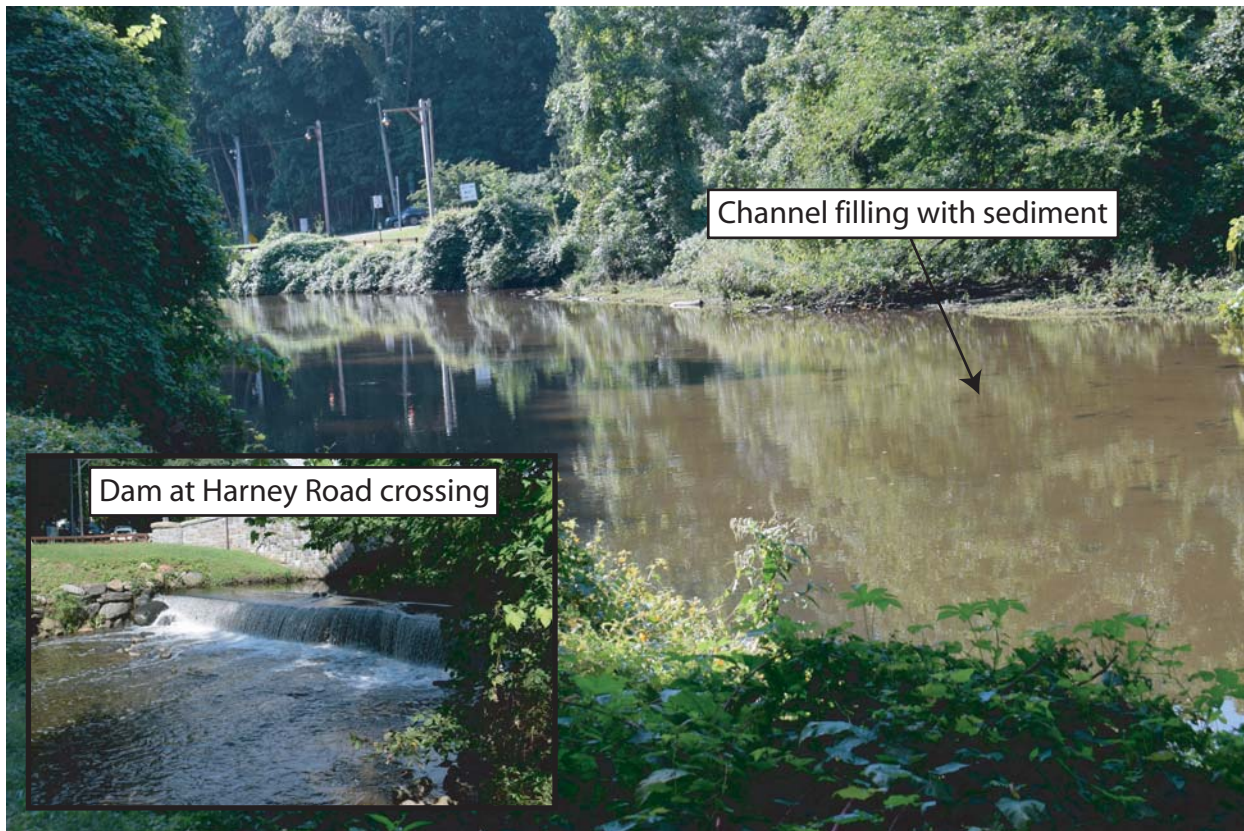
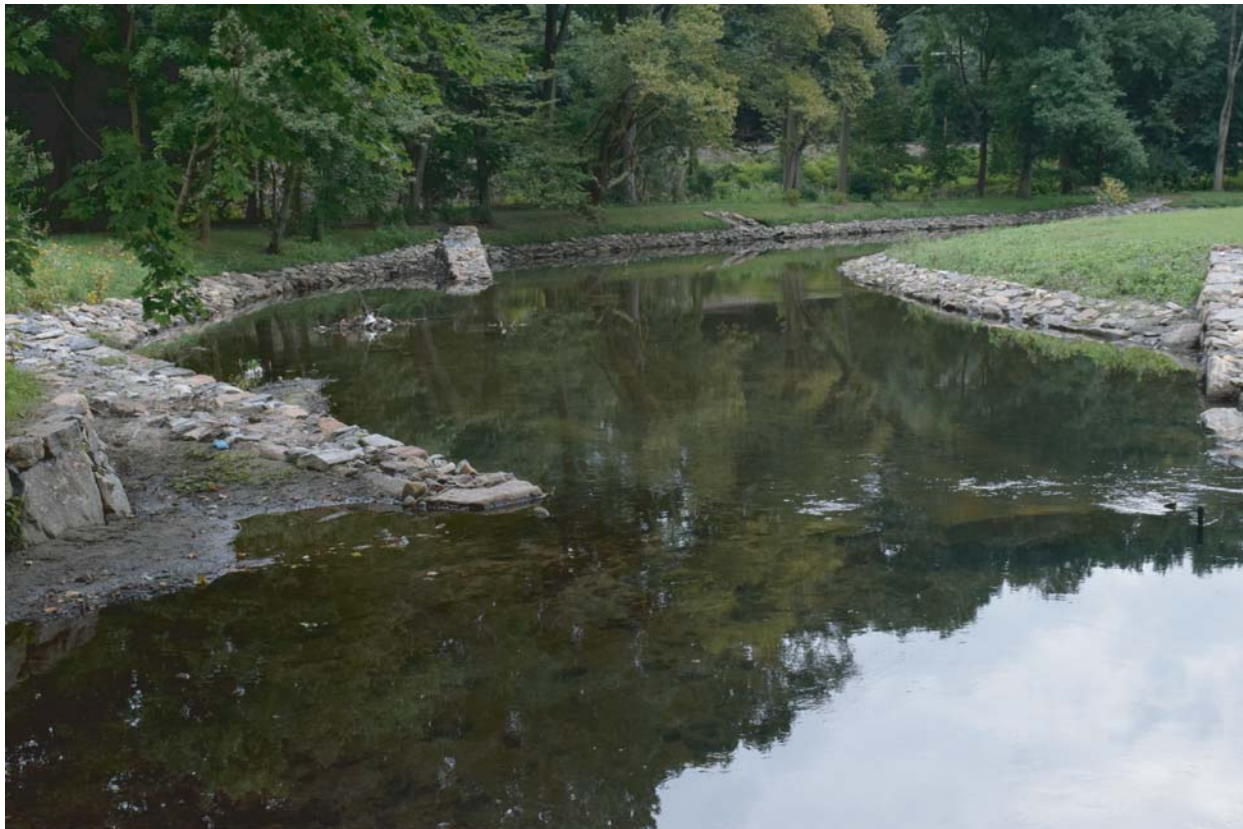
Figure 22. a) Deposition upstream and b) bank armor downstream (to arrest previous erosion) of the check dam at Harney Road.

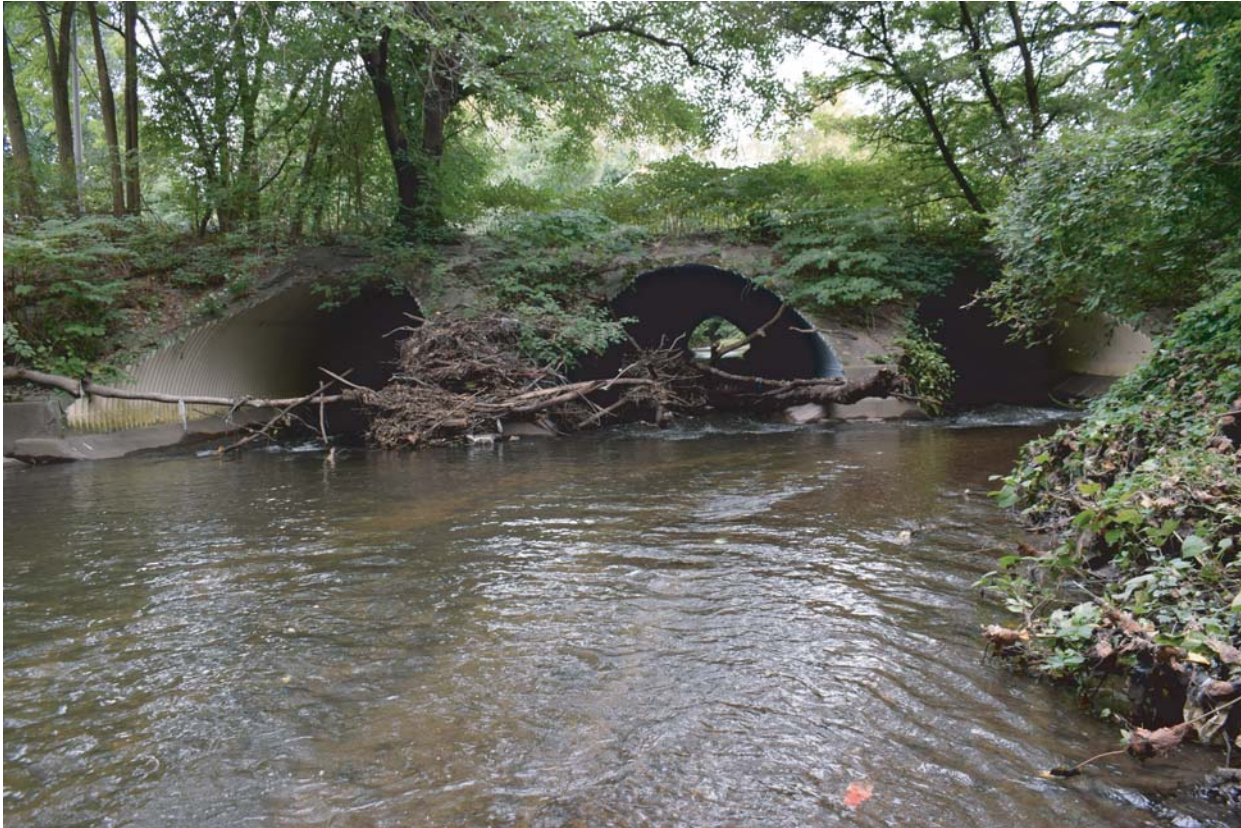
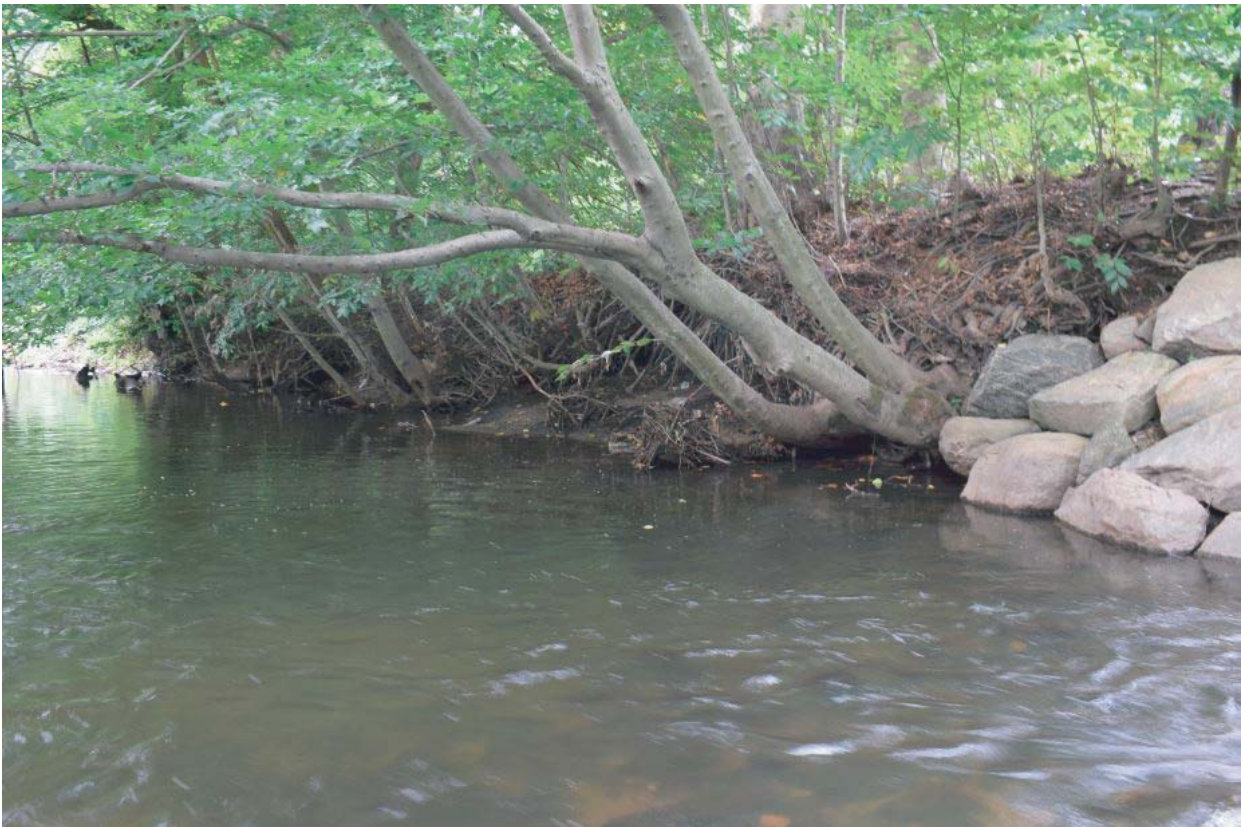
Figure 23. Channel adjustments around undersized stream crossings include a) deposition upstream and b) erosion downstream.

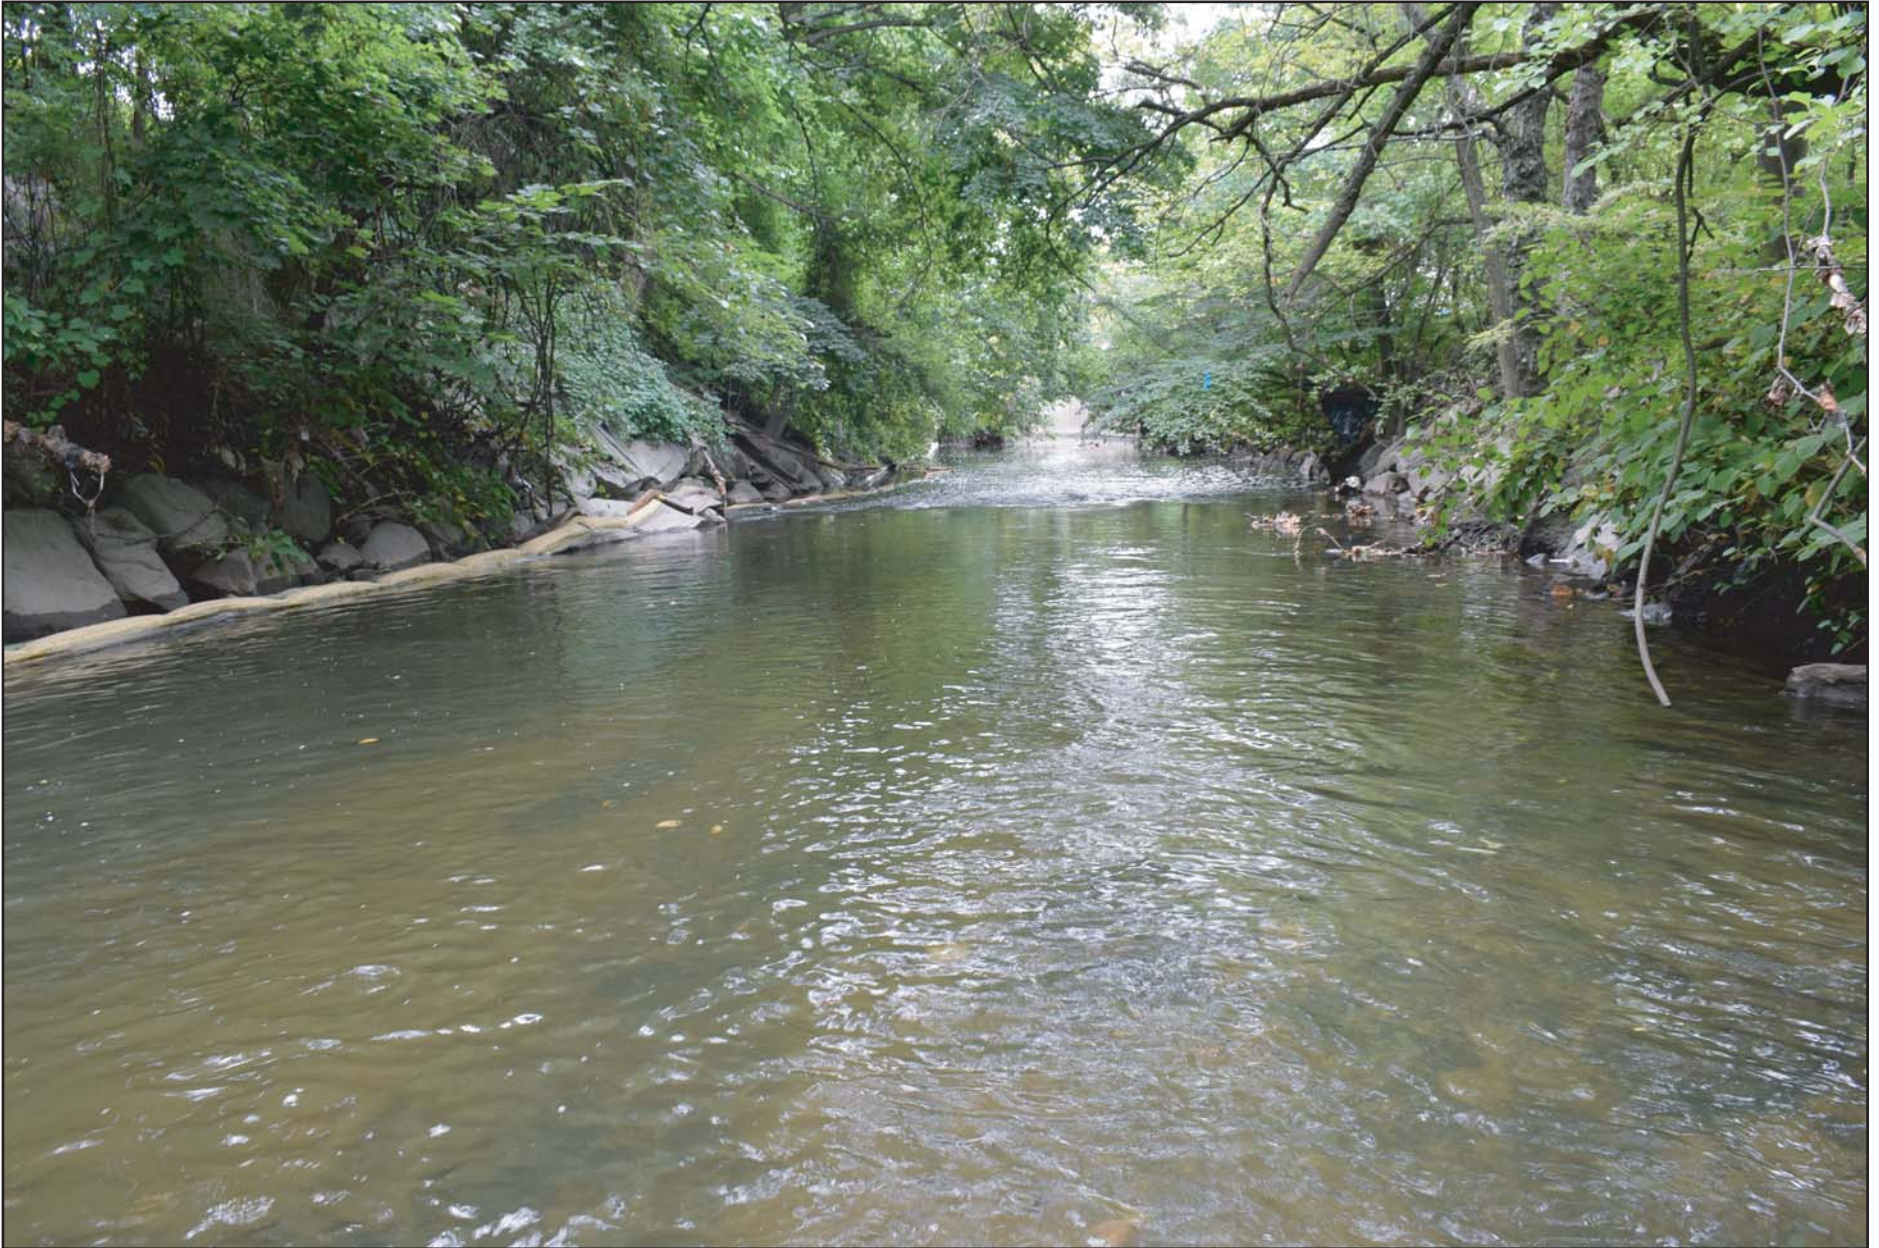
Figure 25. Long straightened sections of the Bronx River are often devoid of any depositional features.

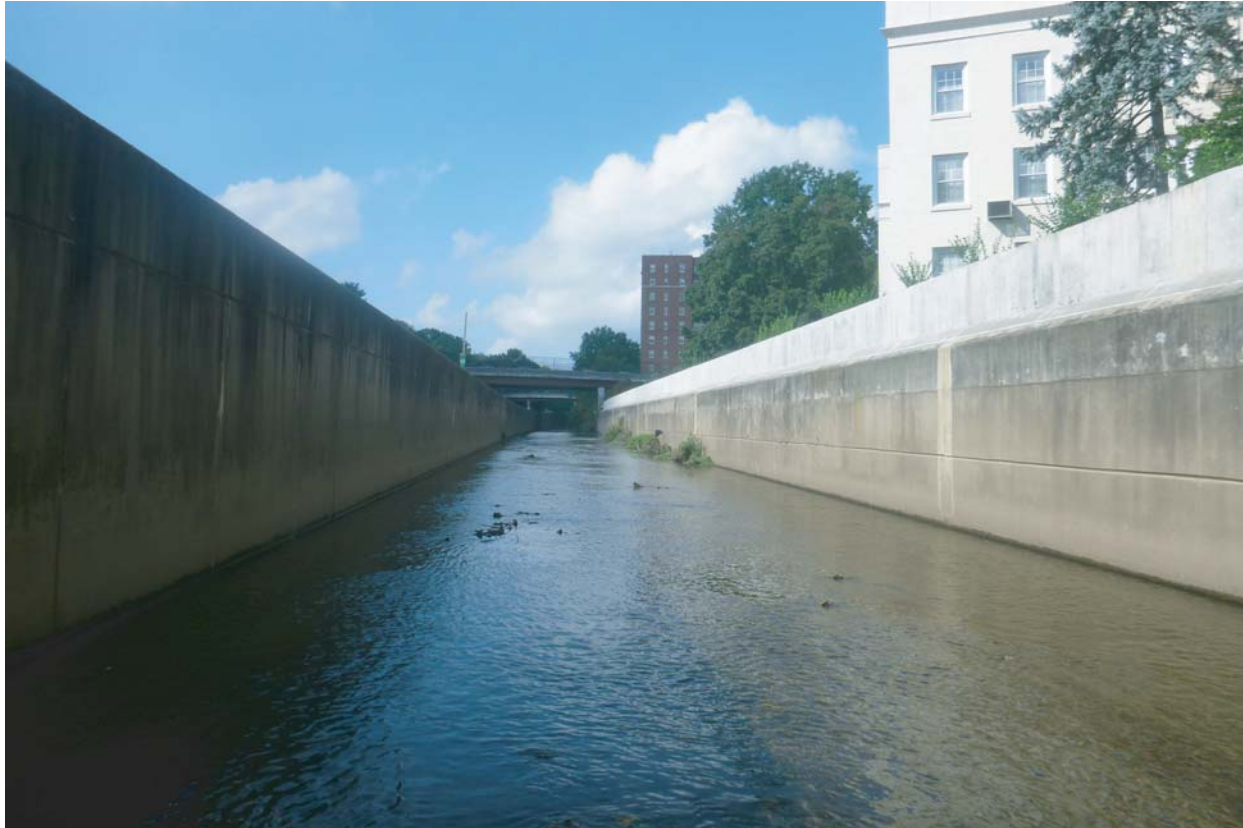
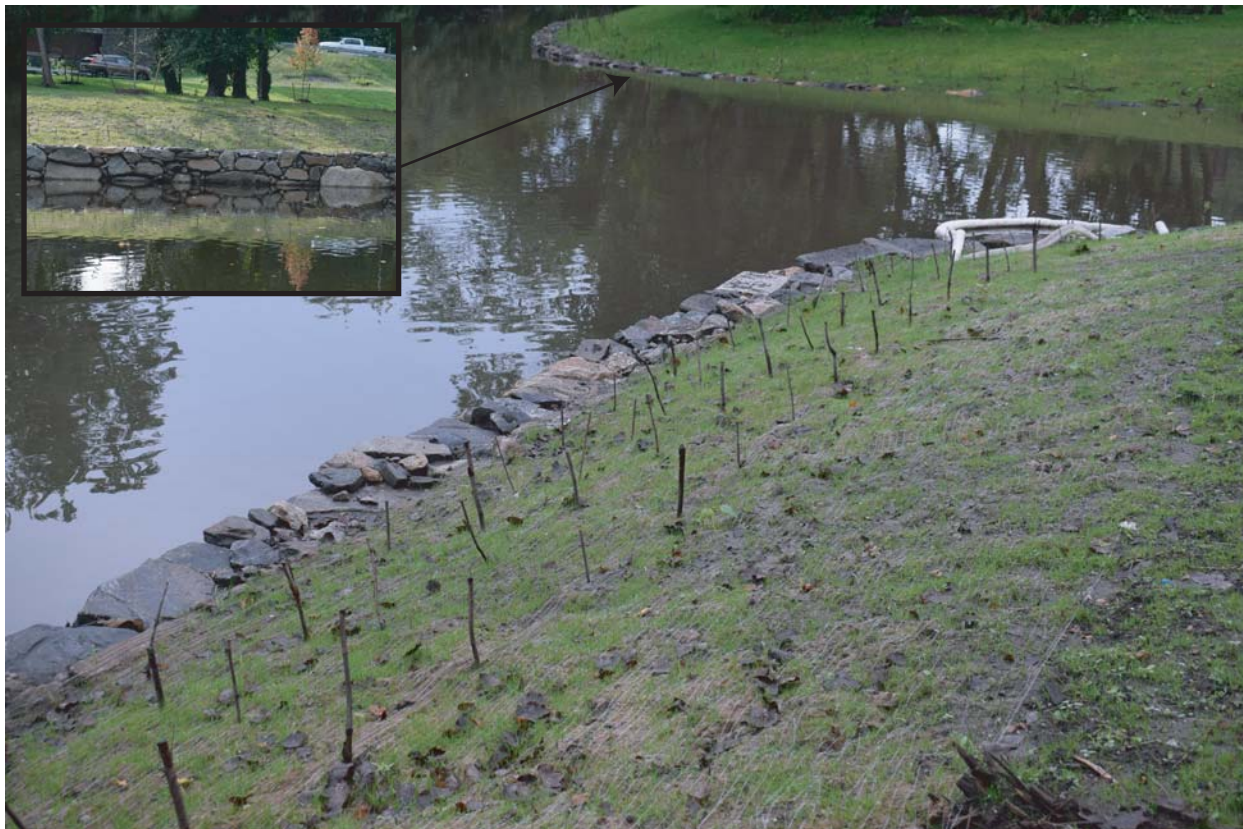
Figure 27. On Grassy Sprain Brook, a) armoring and straightening may be increasing sediment transport and bank instability downstream that led to b) construction of a bioengineering project at the confluence with the Bronx River.

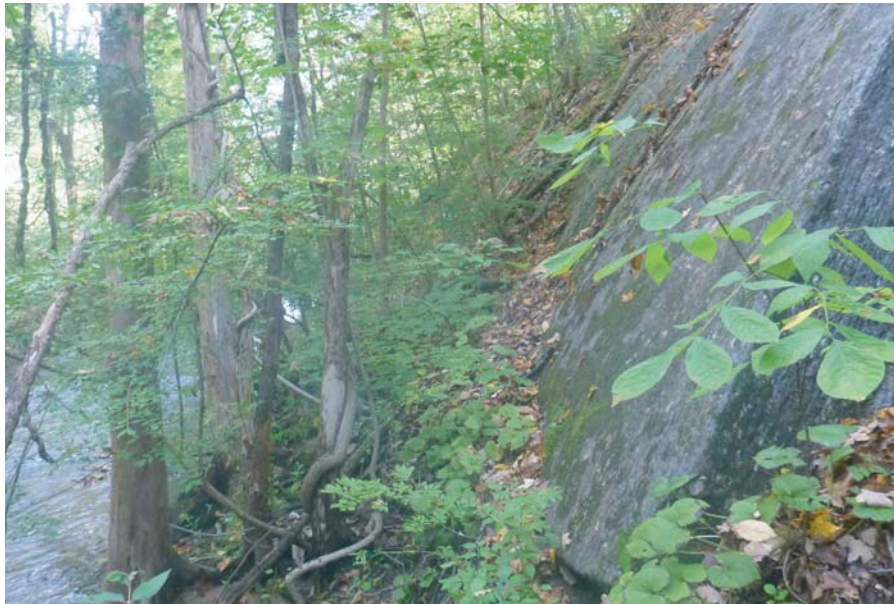
Steep bedrock ledge outcrop along the left bank (BR12D)

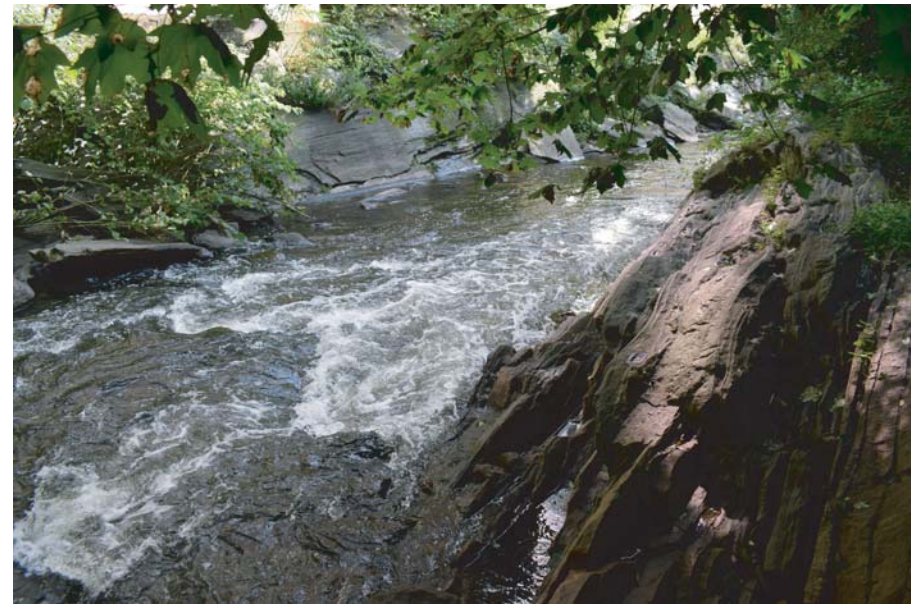
Bedrock gorge downstream of Bronxville Lake (BR06C)

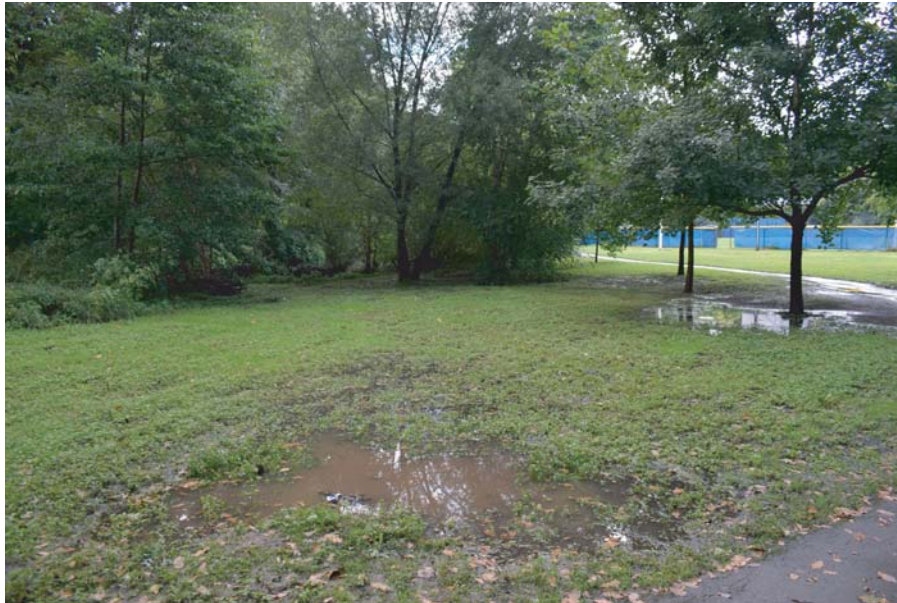
Low floodplain on left bank inundated by recent high water (BR05B)

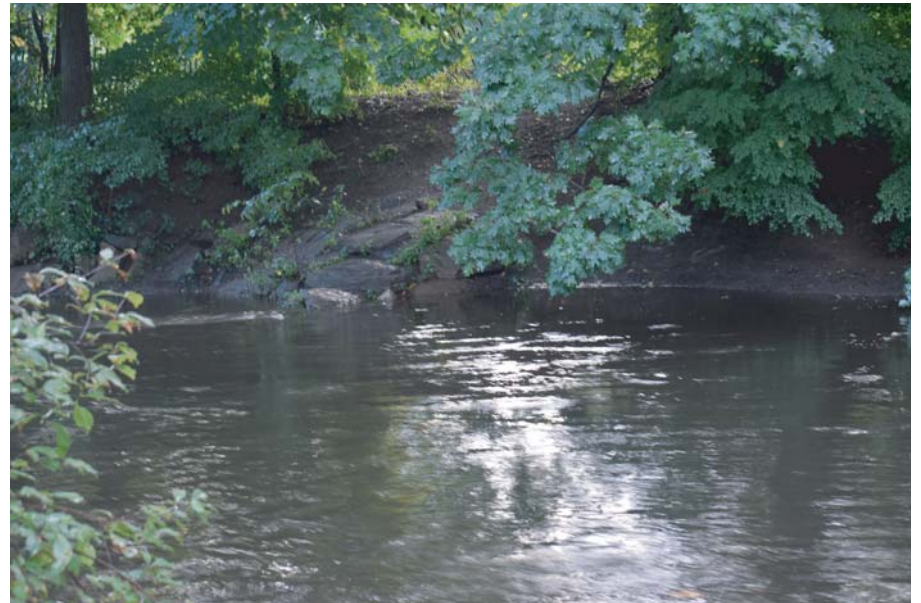
Channel confined by artificial fill along right bank (BR05B)

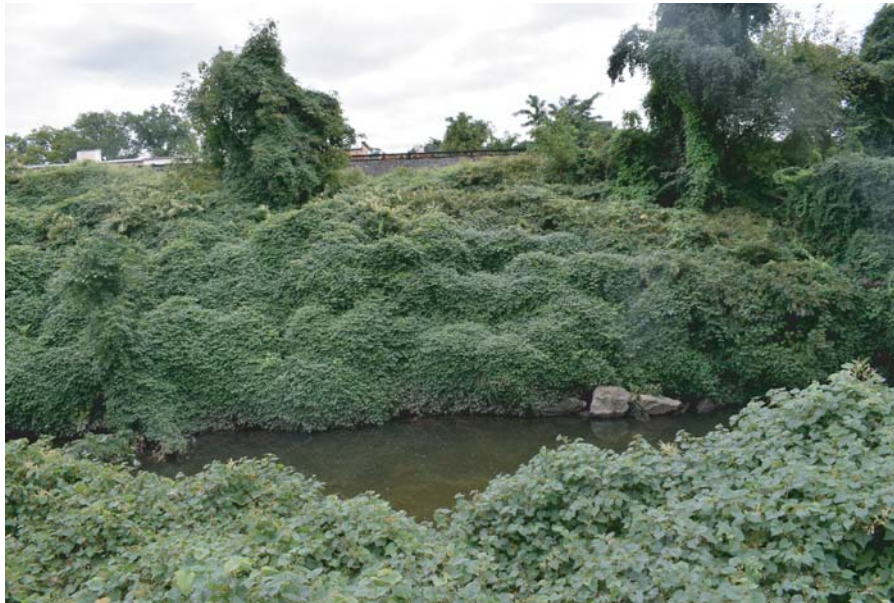
Railroad tracks built upon fill confine the Bronx River along its left bank (BR01B)

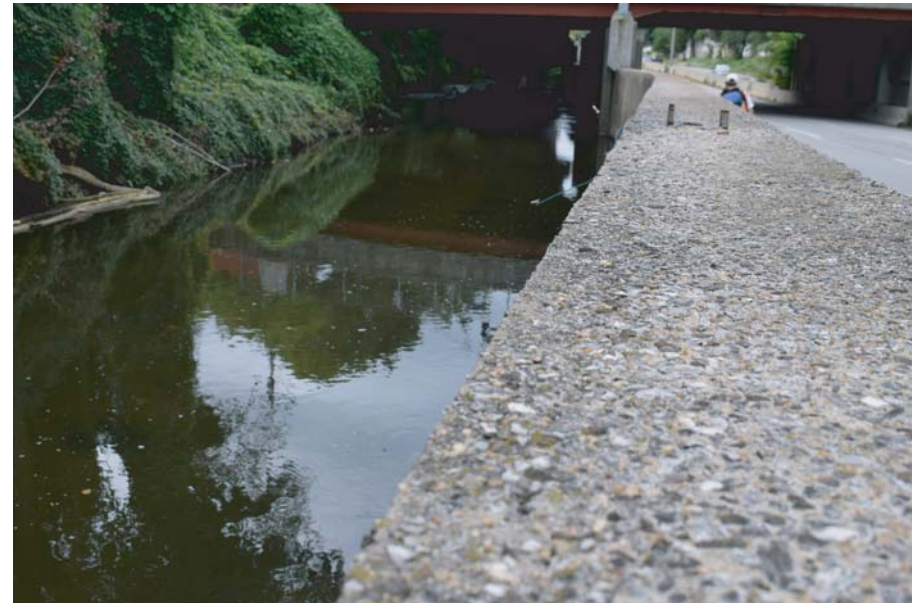
The concrete retaining wall of the Bronx River Pkwy along the right bank (BR02B)

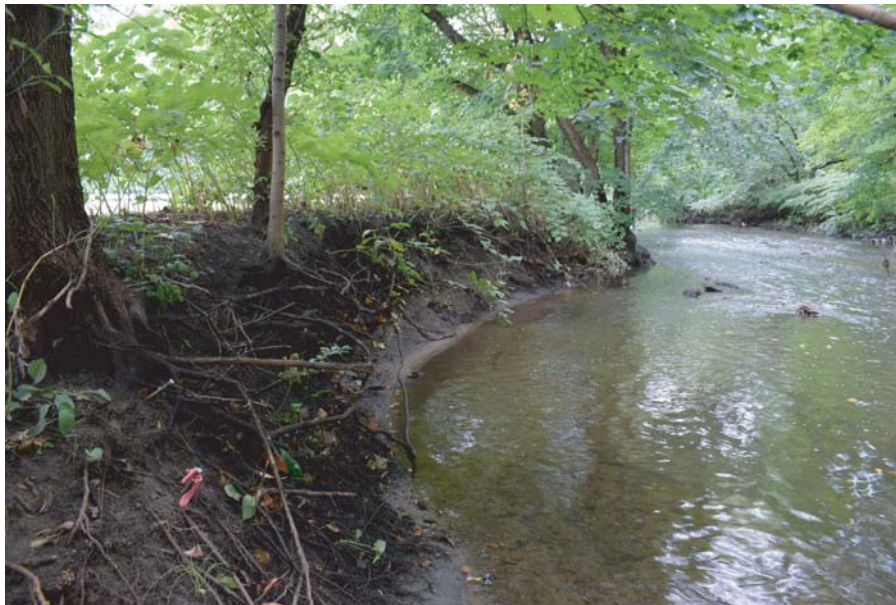
Bank erosion along a forested meander bend (BR10J)

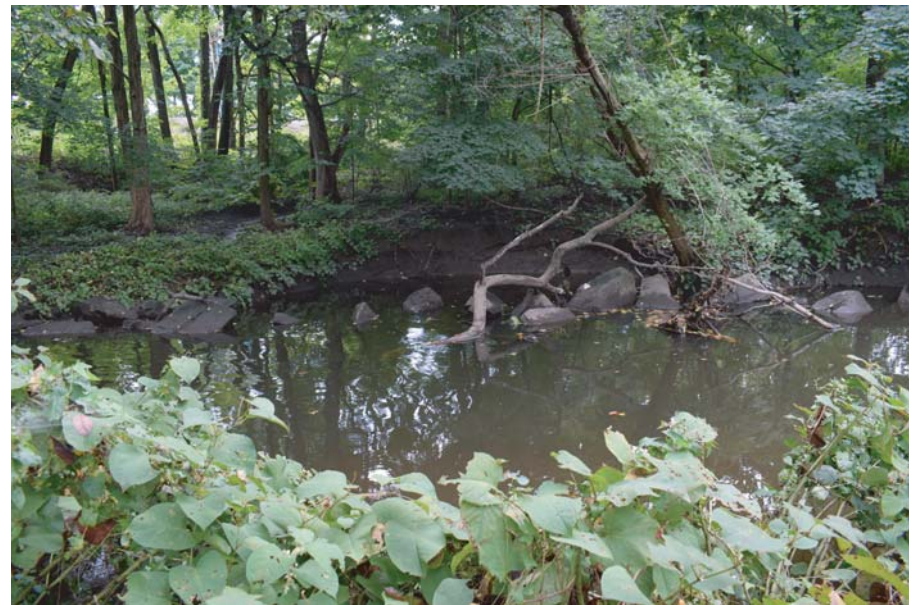
Failed bank armor has been outflanked along the remeandering channel (BR10I)

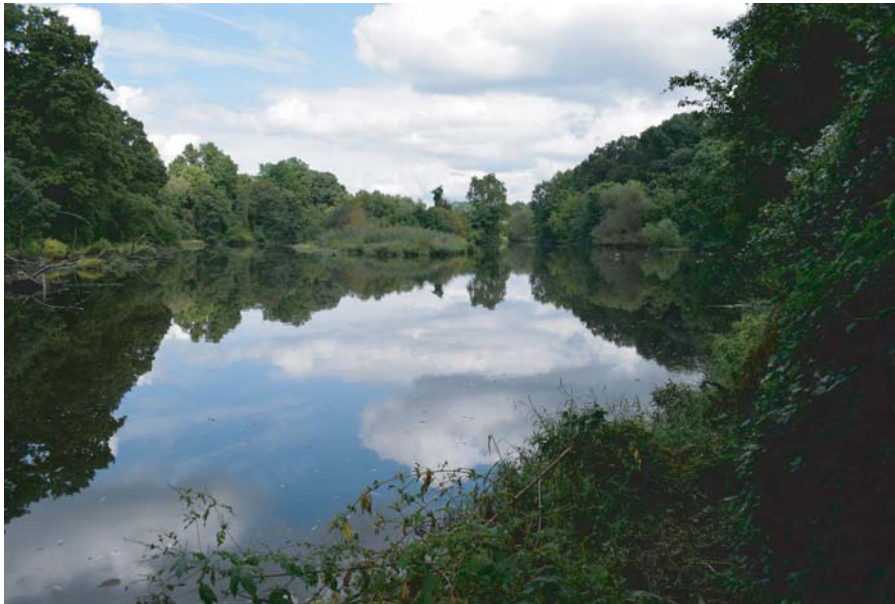
Bronx River impounded to form Crestwood Lake (BR09)
