# **Bronx River Corridor Study and Management Plan for Westchester County, NY – Volume I**

Prepared for  
Westchester County Soil and Water Conservation District  
and  
Westchester County Department of Planning  
White Plains, NY

Prepared by  
John Field  
Field Geology Services  
Portland, ME

July 2019

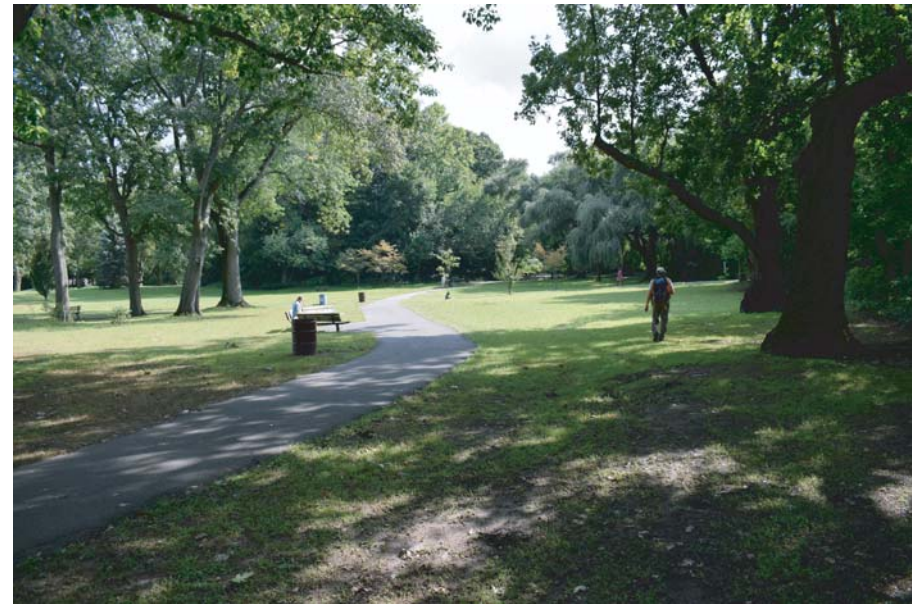
Wide low floodplain along the left bank provides recreational opportunities (BR07)
