Bronx River Corridor Study and Management Plan for Westchester County, NY – Volume II

May 2020

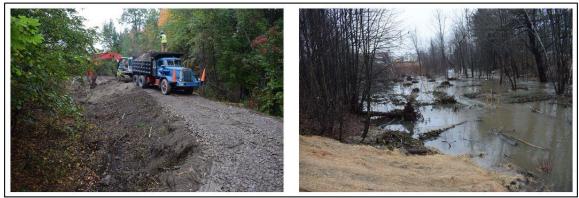
Figure 3. Berm removal (left) on Long Creek floodplain in October 2019 in South Portland, ME resulted in flow on the floodplain for the first time in more than 40 years (right) less than two months later during December 2019 rainstorm.

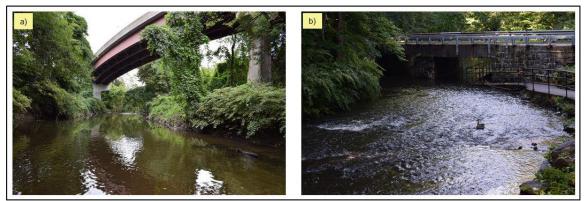
Figure 5. Some bridges a) fully span the bankfull channel of the Bronx River (Grassy Sprain Parkway) while b) others have spans narrower than the channel's bankfull width (Northbound lanes of Parkway in Garth Woods).

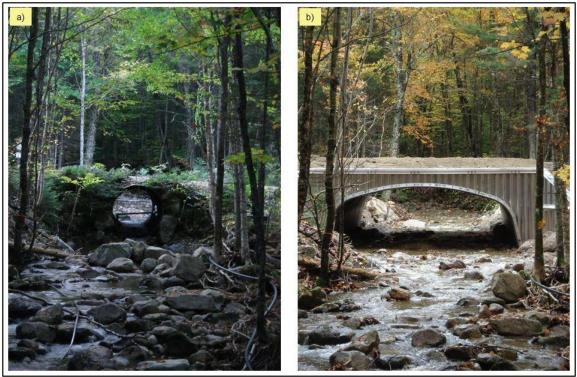
Figure 7. Paired photographs of a stream crossing on Long Mountain Brook in Coös County, NH a) before and b) after resizing the span in September 2008 to accommodate the channel's bankfull dimensions.

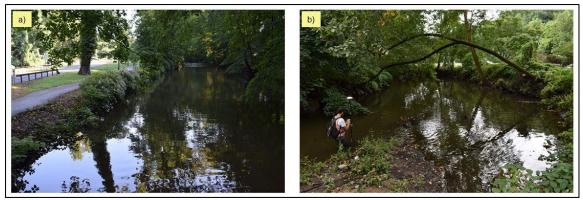
Figure 8. Example of a) artificially straightened channel near Scarsdale Village and b) naturally reformed meander downstream of Harney Road.

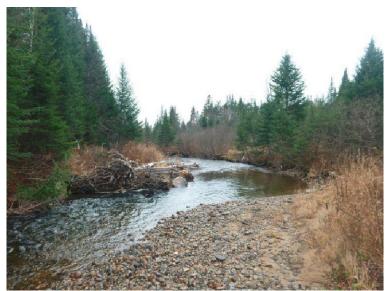
Figure 9. Flow diversion around a marginal log jam is enhancing meander formation on the opposite bank along Nash Stream in Coös County, NH.

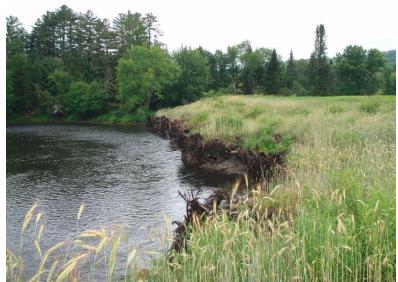
Figure 10. A series of marginal log jams protecting an eroding bank on the Connecticut River in Columbia, NH one year after construction.

While largely used in more rural and agricultural settings (Figure 10), the wood-based biostabilization techniques have also been used in urban and suburban environments as illustrated by some of the photographs in Appendix 1. Given the usually limited space available, wood might be better suited for bank stabilization projects in urban settings, because log jams and crib walls can be constructed vertically with stacked logs. This allows wood-based projects to be built without grading back the bank to a 3:1 or 4:1 slope as required for rock revetments that tend to be unstable if built on a steeply sloping bank. While wood used in log jams and crib walls decompose over time, their life span can be increased dramatically when using rot-resistant species and if the wood remains covered by sediment and brush, providing enough time for natural vegetation on the bank to mature sufficiently with soil-binding root systems that will sustain the bank stability. Furthermore, biostabilization projects may be more durable than rock revetments as projects using interlocking logs tend to work as a single unit withstanding the river's forces while an entire rock revetments can unravel with the displacement of a single rock that exposes the erodible bank material to the river's flow (see Section 4.3a in Volume I).

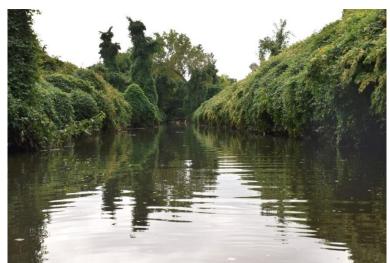
Figure 12. Invasive species are the dominant vegetation on the banks of the Bronx River in some areas, particularly in the lower reaches such as Reach 2 in Yonkers/Mount Vernon shown here.

Invasive species are found nearly everywhere in the Bronx River corridor but are often the dominant vegetation (Figure 12) where no mature riparian forest is present or unless landscaped vegetation is maintained (i.e., mown grass in parks). Establishing a mature riparian forest where invasive species predominate is difficult as young trees are often crowded out by invasives unless significant shade is present from taller trees. In addition to inhibiting forest vegetation from becoming established in the corridor, invasive species also compromise aquatic habitat since 1) a shaded canopy to keep water temperatures low in the summer is unlikely to develop if no trees are growing on the bank; 2) wood cannot be recruited into the channel if no trees are present to fall into the river; and 3) the poor root systems of most invasive species will compromise the bank stability otherwise provided by the roots of mature trees. Therefore, invasive species control and riparian plantings would not only fulfill the BRCSMP objectives of invasives species control and enhance natural riparian vegetation but also enhance aquatic habitat.

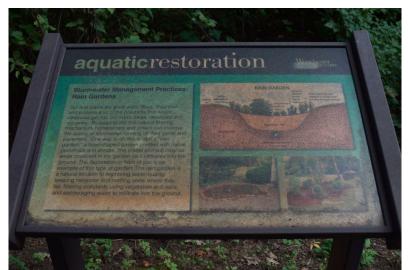
Figure 13. Interpretive signs enrich the user experience along the recreational path along the Bronx River, but new ones could better reflect BRCSMP priorities and activities.

The long continuous path along much of the Bronx River in Westchester County provides an opportunity for biking, jogging, and walking. User experience along the river is further enriched by interpretive signs (Figure 13), benches, parks, and perhaps occasional ice skating in impoundment areas. Swimming may have occurred in the past but deposition and encroachment of emergent wetlands within the impoundments has presumably greatly reduced this activity. The landscape today is vastly different than what met the earliest European settlers and is a tremendous improvement over the polluted river of the late 19th and early 20th centuries. As restoration efforts of the BRCSMP continue the river's reclamation towards a more natural condition, additional recreational opportunities not available along the river for centuries may reemerge. Developing recreational opportunities will not only directly achieve that eponymous BRCSMP objective, but increased interaction with the river should also increase public support to achieve other BRCSMP objectives.

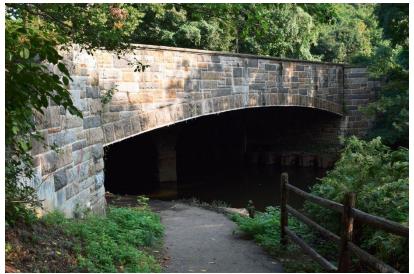
Figure 14. The railroad bridge just downstream of Parkway Avenue is an excellent candidate for resizing based on the hazard mitigation and aquatic habitat enhancement benefits that could potentially accrue.

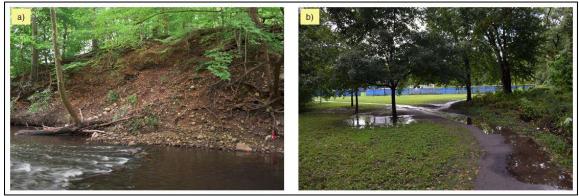
Figure 15. At Scout Field (Segment BR_05B), a) a high bank of artificial fill blocks the floodplain across from b) a ball field that experiences persistent flooding as a result.

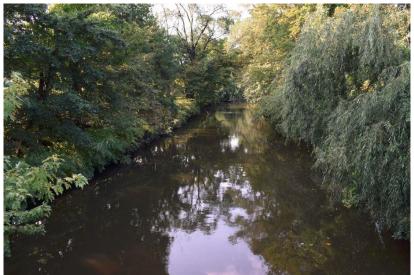
Figure 18. The Dewitt Avenue restoration reach looking upstream from Parkway Road Bridge.

The Dewitt Avenue restoration reach (Figure 18) has three bridges including the railroad bridge at the downstream end of Segment BR_5D, Parkway Road Bridge just upstream, and Dewitt Avenue Bridge near the confluence of Grassy Sprain Brook at the upstream end of the segment. The railroad bridge has the greatest hydraulic impact of any crossing along the river in Westchester County given its highly constrictive nature (Figure 14). The length of this restoration reach, comprised of only a single segment, is over 1,100 ft. Reducing the backwatering resulting from the undersized crossings could mitigate hazards not only in Segment BR_5D but other segments further upstream and up Grassy Sprain Brook. Hazard mitigation is a high priority objective in this segment with three other priority objectives (i.e., weighting of 4 or 5) scoring high enough (i.e., > 10) to be worthy of addressing (Table 4). A need for recreational improvements has a maximum score of 8 for this reach but limited space other than across from the Grassy Sprain confluence severely constrains the development of new opportunities. The topographic survey of the restoration reach documents a bankfull width of 96 ft, an intact floodplain across from the Grassy Sprain Brook confluence, and a significant channel constriction at the railroad bridge (Appendix 3).

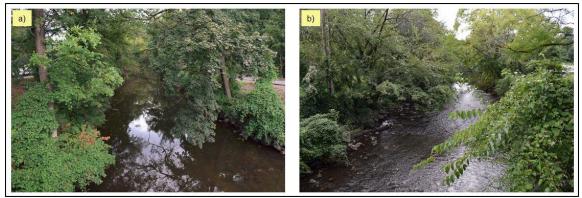
Figure 19. The Crestwood Station/Thompson Street restoration reach a) looking upstream (access road to County maintenance facility visible on right side of photo) and b) looking downstream from Thompson Street Bridge.

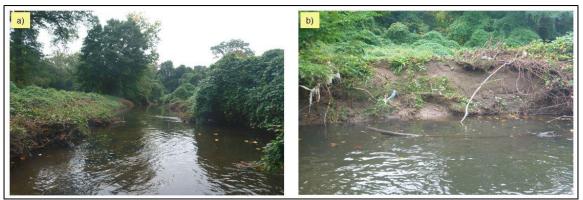
Figure 21. The County Center restoration reach a) upstream of the Parkway bridge (looking downstream) and b) showing bank erosion downstream of the Parkway bridge that contribute fine sediment to the reach.

Segments BR_16E through 17B is in the vicinity of the Westchester County Center (Figure 21). The combined length of this restoration reach is nearly 2,675 ft. Restoration adjacent to the County Center provides an opportunity to reach thousands of residents that may otherwise be unaware of the BRCSMP. Four objectives are highlighted as priorities in this reach, one in BR_16F and three in Segment BR_17A: hazard mitigation, control invasives, enhance natural riparian vegetation, and improve recreational opportunities (Table 4). Restoring aquatic habitat and improving water quality are other priority objectives (i.e., weighting of 4 or 5) that require addressing (score >10) as adequate floodplain connectivity and natural river processes (e.g., meanders) are already present. The topographic survey of the restoration reach documents a bankfull width of 43 ft, a floodplain unblocked from the river channel except at the bridges, and a channel constriction at the bridge carrying the Parkway's northbound lanes (Appendix 3).

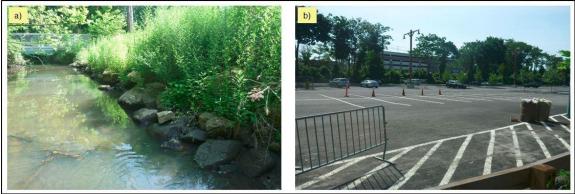
Figure 22. The Fisher Lane/North White Plains Station restoration reach showing a) the armor protecting the bank of artificial fill downstream of Fisher Lane (upstream view) and b) the parking lot built on that fill where the Bronx River used to flow prior to filling.

located. Now, the Bronx River is confined between a natural elevated bedrock knob on the right bank and bank armor protecting the parking area from erosion (Figure 22). The combined length of this restoration reach is over 1,600 ft. The bedrock knob provides an opportunity for recreational improvements near the heavily used rail station. Five objectives are highlighted as priorities in this restoration reach: hazard mitigation, enhance aquatic habitat, restore natural processes, enhance natural riparian vegetation, and improve recreational opportunities (Table 4). Segment BR_19 is highlighted as a segment with one of the highest cumulative prioritization scores, indicating the importance of restoration in this area. Floodplain reconnection is another high priority objective (i.e., weighting of 4 or 5) that requires addressing in Segment BR_19. The topographic survey of the restoration reach documents a bankfull width of 33 ft (under severely constrained conditions, so naturally would be higher), an intact floodplain upstream of Fisher Lane, and a channel constriction at the Fisher Lane Bridge (Appendix 3).

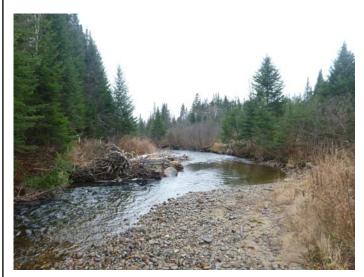
Constructing log jams to encourage meander growth (Nash Stream, Stark, NH)

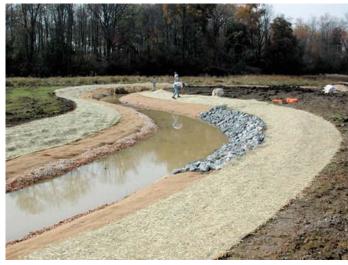
Excavating meanders utilizing natural channel design principles (http://www.landandwater.com /features/vol46no2/vol46no2_1.html)

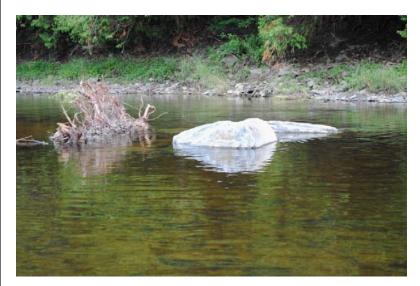
Boulder cluster w/ partially buried log (Meduxnekeag River, Houlton, ME)

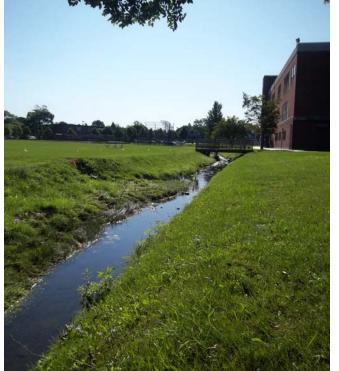
Before: Mowed grass buffer along degraded channel (Monroe County, NY)

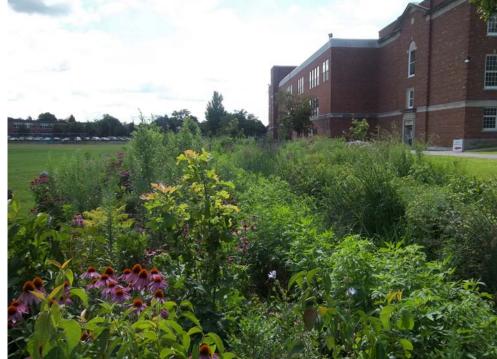
After: Restored riparian buffer planted with native plants and flowers (https://www.monroecountyswcd.org/Streamprojects.html)

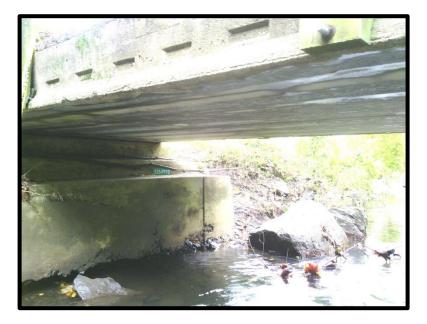
Figure A2-1: Photo of erosion removing protective material at a bridge on the Bronx River (BIN 3364910), leading to cracking of abutment's concrete.

The second hazard category assessed as part of the BRCSMP was bank erosion. Erosion occurs when the physical strength of rushing water exceeds the cohesion strength of the bank material along the river. Bank erosion can be hazardous when damage to nearby infrastructure is possible such as on the Bronx River where material adjacent to and below a bridge abutment was removed resulting in the abutment's concrete cracking (Figure A2-1).

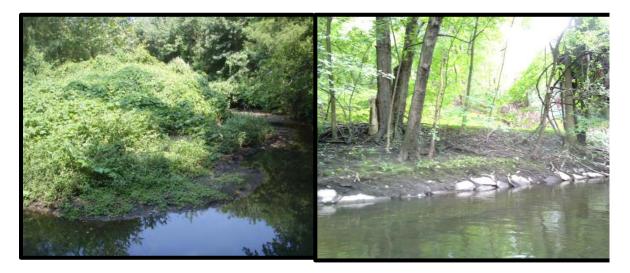
Figure A2-2. Invasive species make river access difficult (left) compared to where they are absent (right).

Invasive species colonize areas and create a dense thicket that makes access to the river challenging where they represent the dominant vegetation (Figure A2-2). For these reasons invasive species control, in particular invasive plant species is desirable.

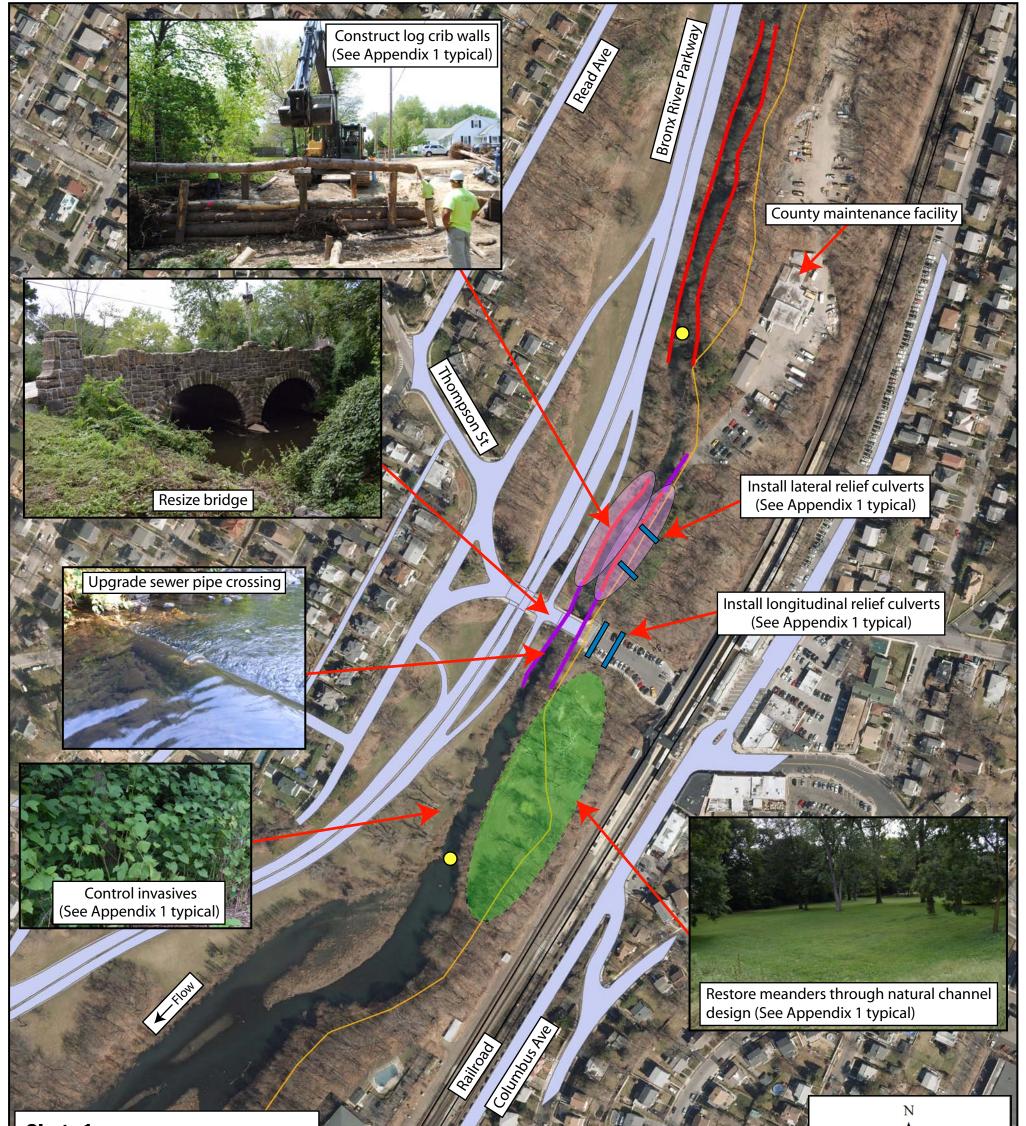
Stage 1

1. Control invasives

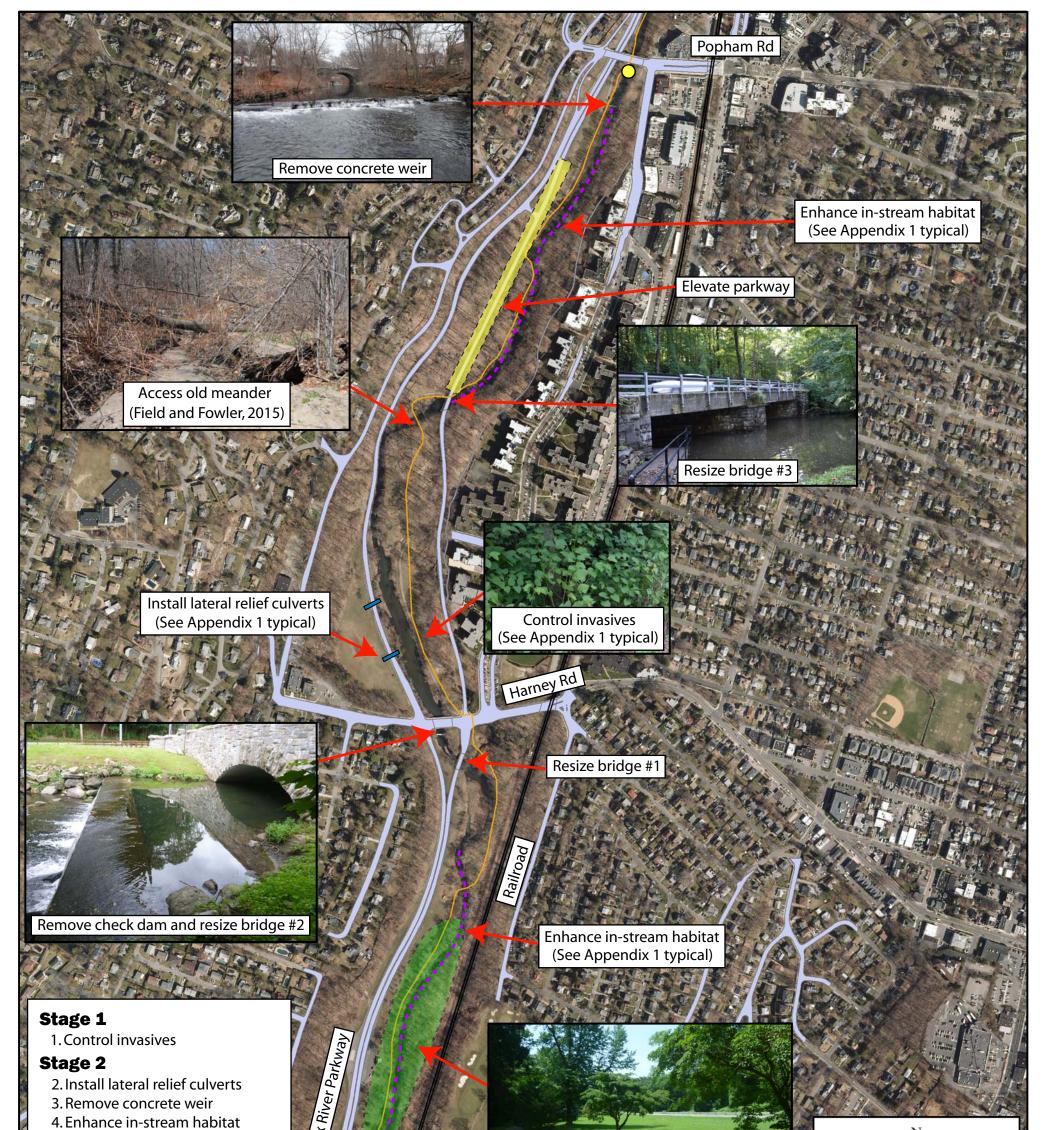
5. Access old meander

6. Restore meanders
